## RIVER BEAULY HYDRO-MORPHOLOGY REPORT 2023

Report prepared by Ruth Watts, Senior Biologist | DRAFT, 24/10/23

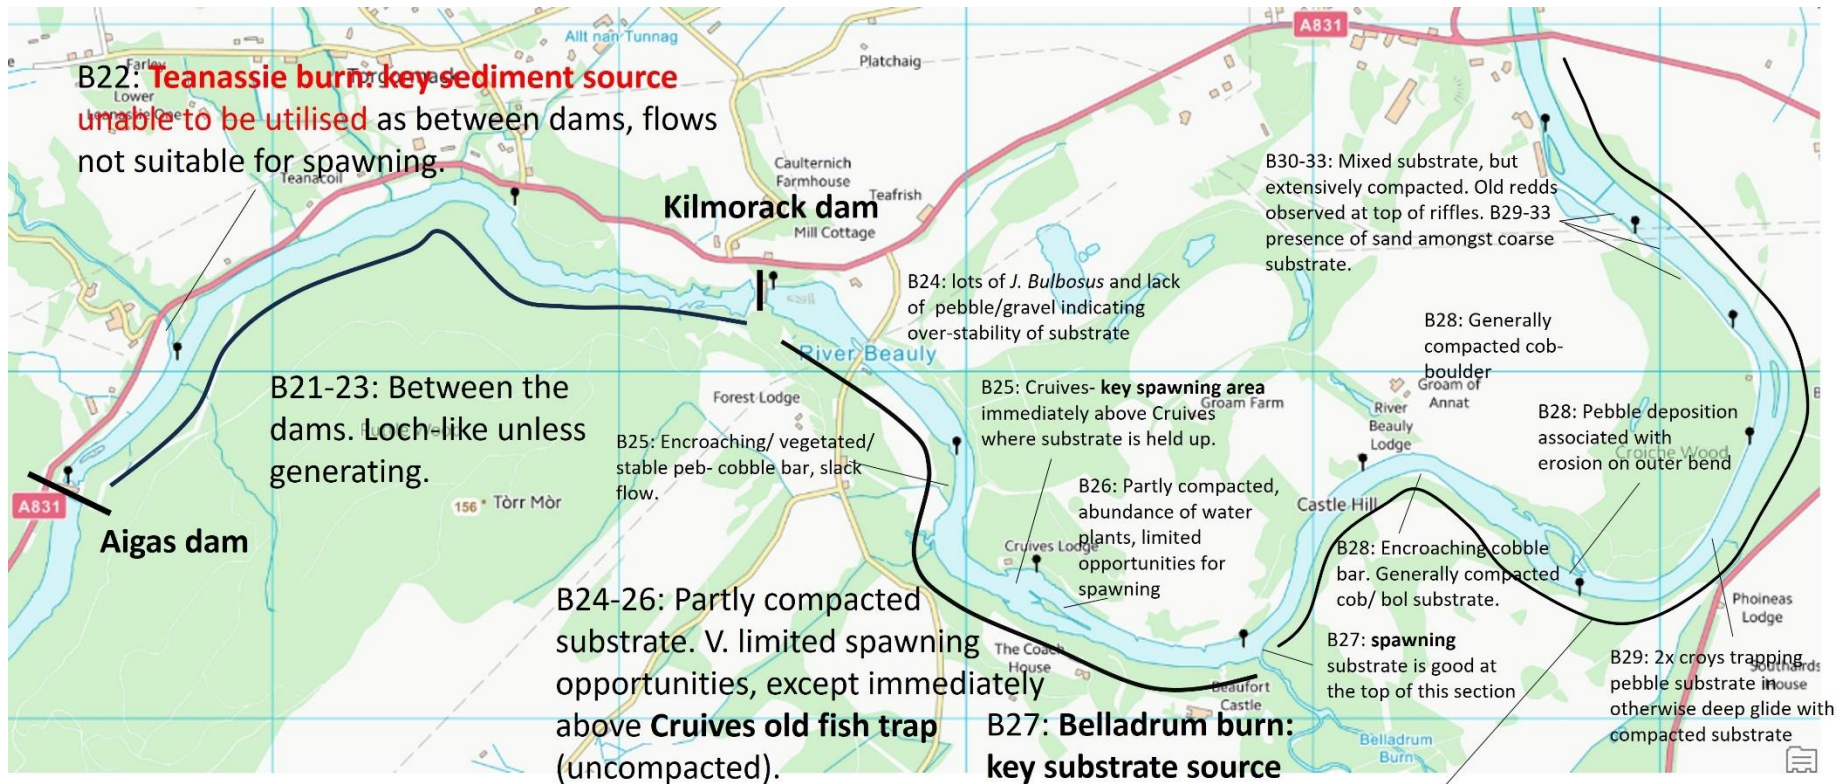
Map 4: Aigas dam to Lovat bridge

B27-33: Although Belladrum burn is providing substrate to this section and spawning does occur, the lack of spate flows on the Lower Beauly is causing compaction, over-stability and encroachment of the banks. This is limiting the usefulness of potential spawning substrate and limiting spawning opportunity.

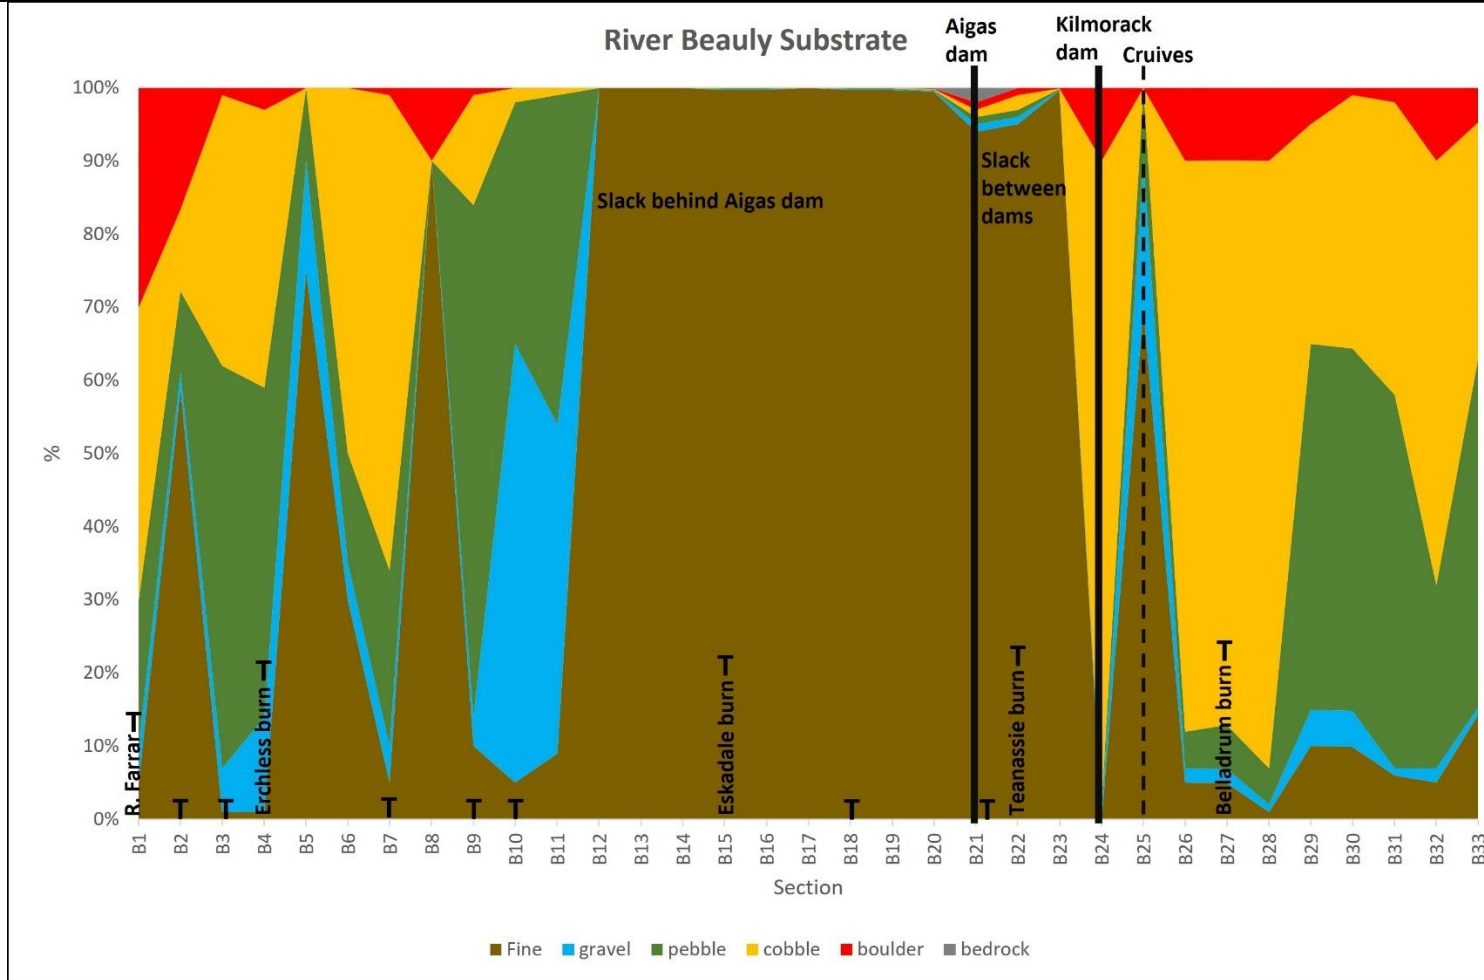
Figure 1: Graph of substrate recorded in each section. T= tributary providing substrate.

Figure 1 may show that **there is a lack of gravel substrate below Kilmorack compared to above the dams. There is also a predominance of cobble below the dams when compared to above which may suggest a coarsening of substrate in sections B24-B29.**

**Not shown by Figure 1 is that the main difference in substrate composition above and below the dams is compaction (generally uncompacted above, compacted below) and also how the fines are distributed amongst coarse sediment. Where high levels of fines were recorded above the dams this was generally deposited in discrete areas associated with slow/ no flow rather than occurring in amongst useful coarse substrate. 'Fines' as an indicator were recorded in the lower sections B28-B33 (below Beaully Lodge- Lovat bridge) and may be part of the natural partitioning out of Belladrum burn substrate.**

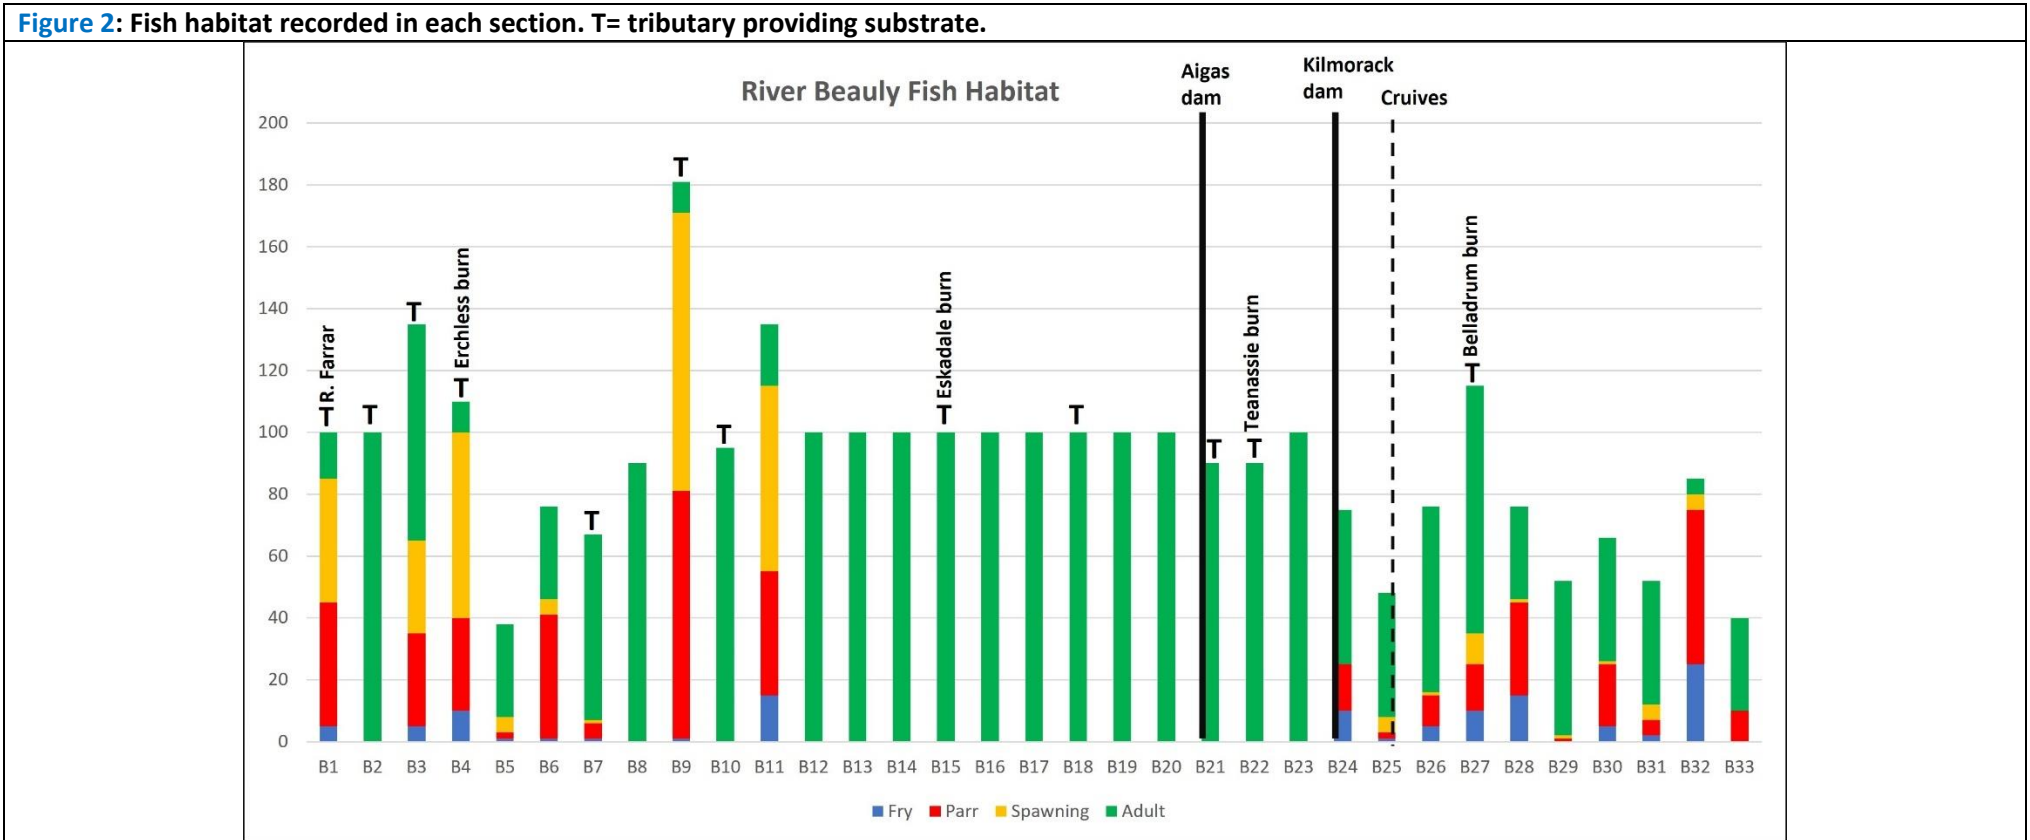
Figure 2: Fish habitat recorded in each section. T= tributary providing substrate.

**There is relatively less spawning habitat available to adult salmon downstream of the influence of Aigas dam compared with above.**

**This is despite the contribution of Belladrum burn and is partly due to the lack of gravel but mostly down to the compacted nature of the substrate and presence of fines** (as previously highlighted in 4.1). Substrate was partly compacted in sections B24-B29 (Kilmorack dam-above Downie hut) and extensively compacted B30-B33 (Above Downie hut- Lovat bridge). The presence of fines interfering with spawning substrate quality was recorded in the lowest sections (B29-33).

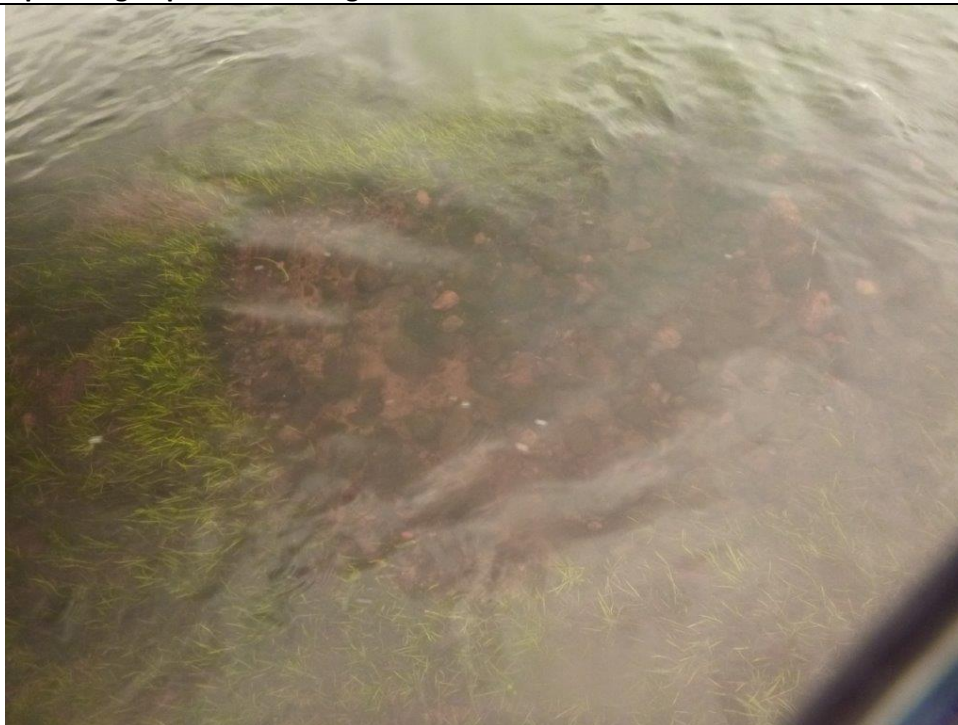
**Photo 5: Spawning depression amongst *Littorella* in section B31. P1040956.**

This suggests that fish are using sub-optimal habitat to spawn in due to a lack of abundant, suitable, uncompacted substrate. **Substrate quality is likely to continue to deteriorate in the future without improved sediment management/** recharge from further upstream.

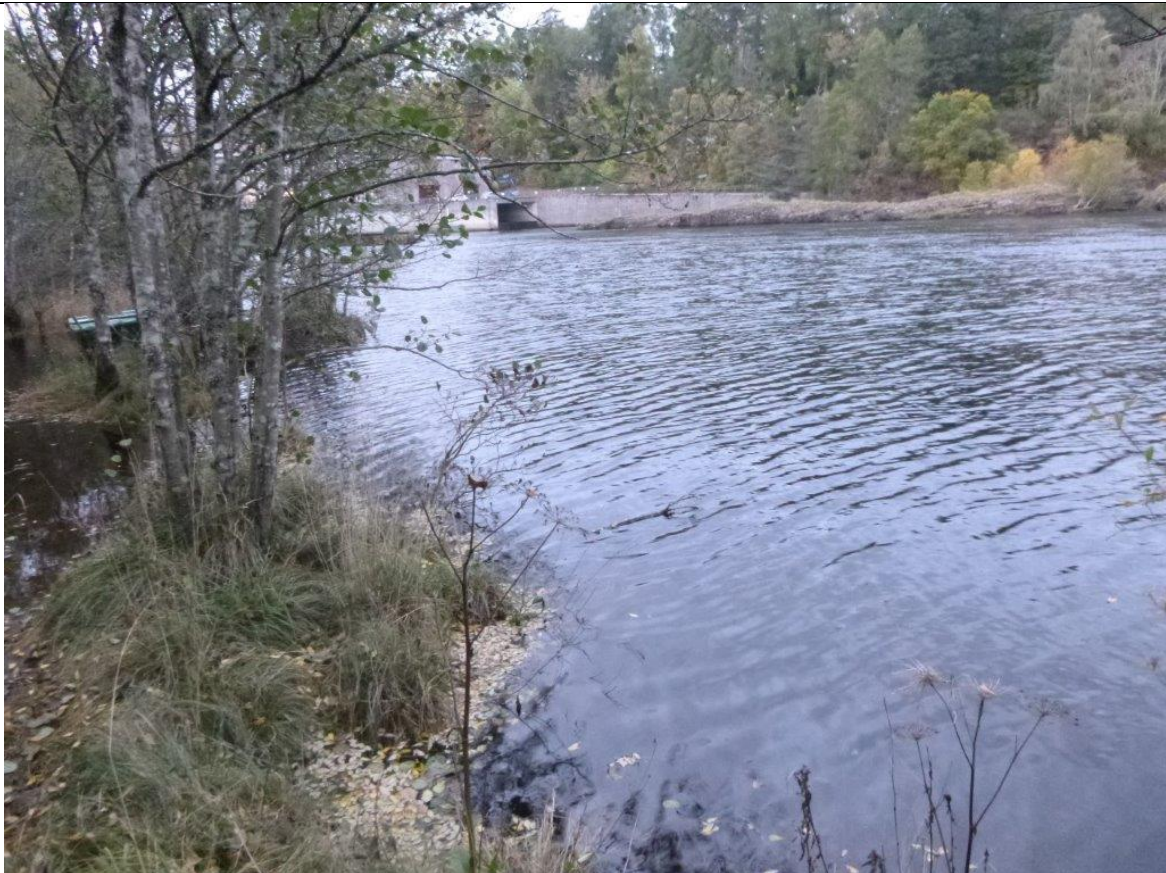
**1) Immediately below Kilmorack dam; NH49449 44106, 19/10/23. Water level higher so substrate not visible, encroaching bank. Walkover (section B24) shows substrate to be predominantly cobble-boulder now.**

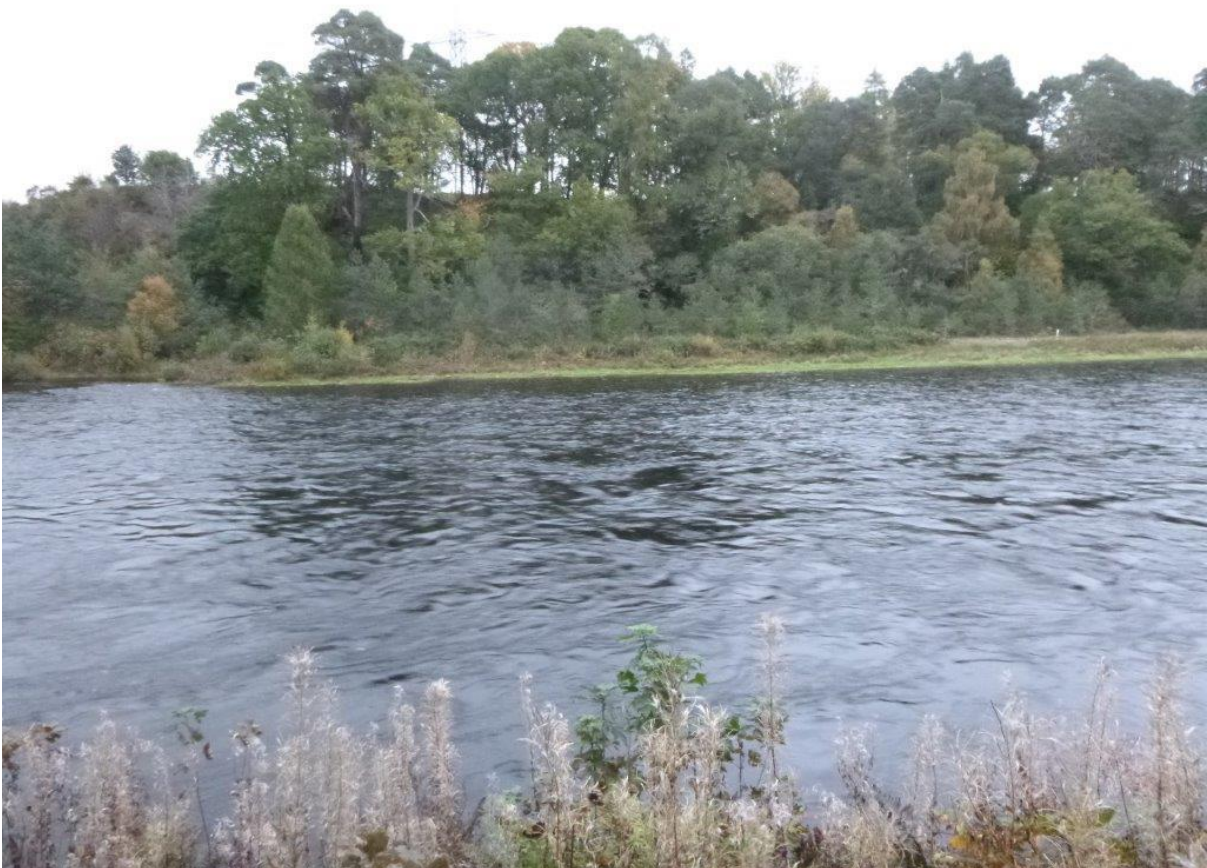
2) Taken from downstream Black bridge. NH49741 43975, 19/10/23. Gravel bar overgrown with trees i.e. stable and undynamic. Also abundance of macrophytes highlighted during walkover (B24).

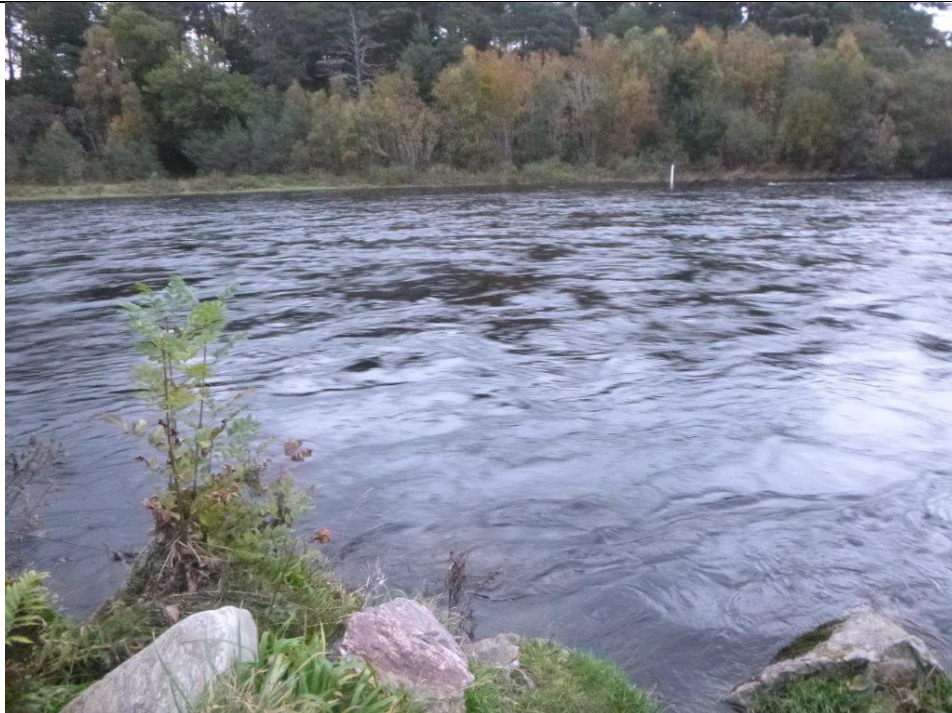
**3) Taken from Falls hut. NH49806 43924, 19/10/23. Bar stable and overgrown. Also flows higher but cobble substrate now boulders. Walkover section B24.**

Anglers who have fished Falls beat for years comment that it is getting more hazardous to fish there due to the now bouldery nature of this beat.

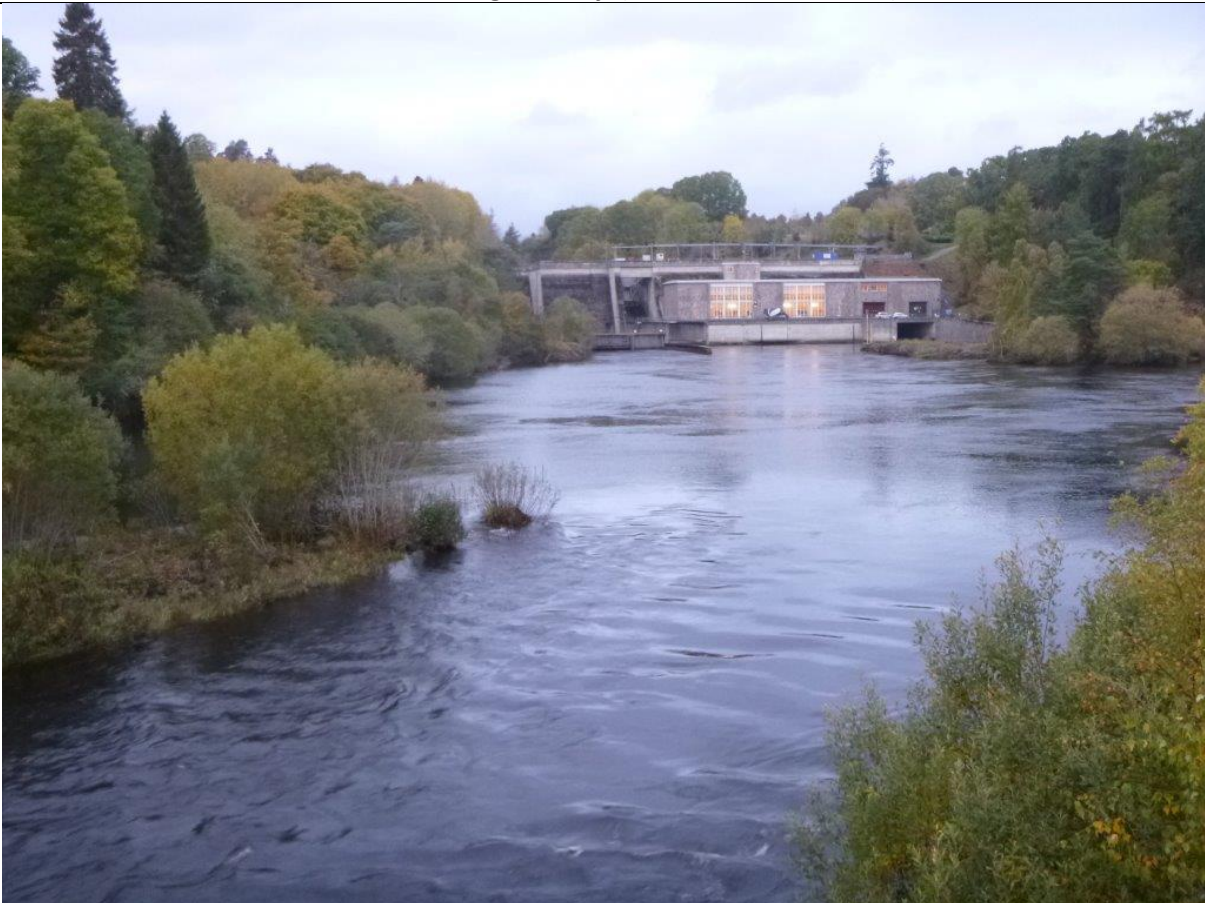
**4) Looking up to Kilmorack dam (where falls used to be) from Black bridge. NH49725 44074, 19/10/23. Island has appeared where cobble riffle used to be, showing stability. (Walkover section B24).**

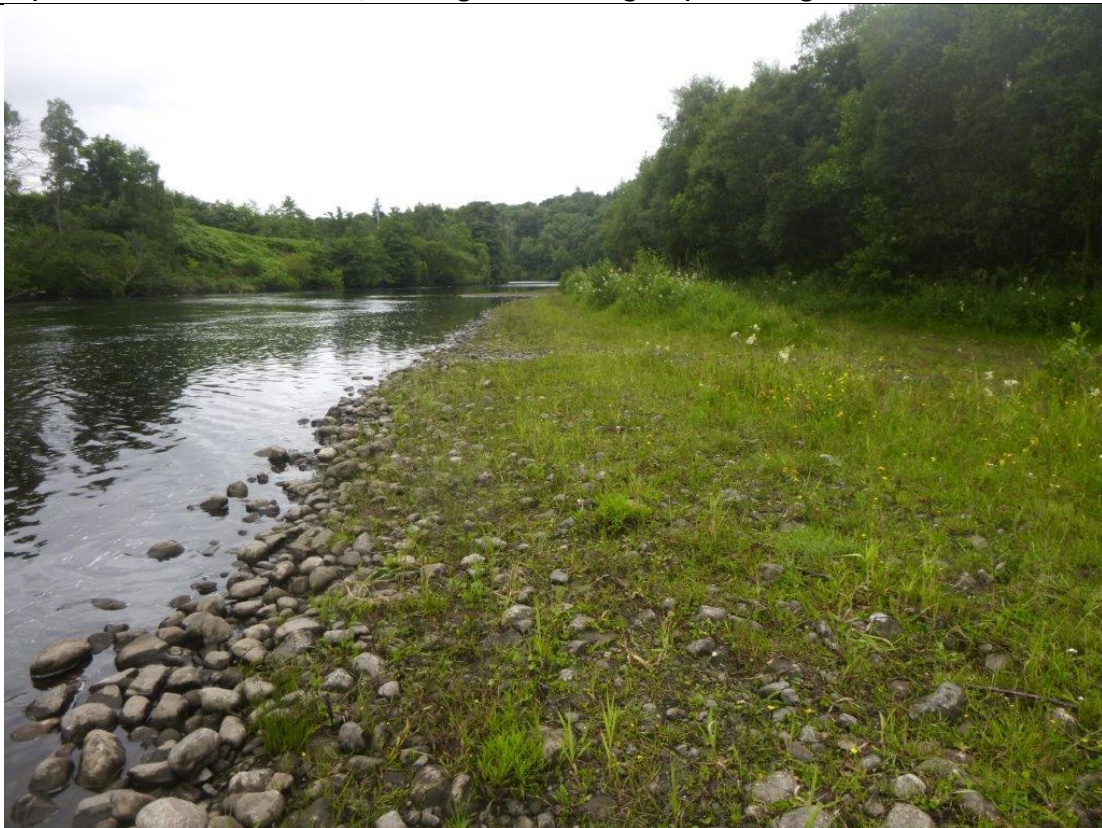
5) Downstream of Black bridge, Kilmorack, New Pool. NH49961 43726. 12/07/2023. Unfortunately the view from the same vantage point is now blocked by trees, however this bar is in walkover section B25 so walkover photo p875 included (taken further downstream, from right bank along bar). Now vegetated.

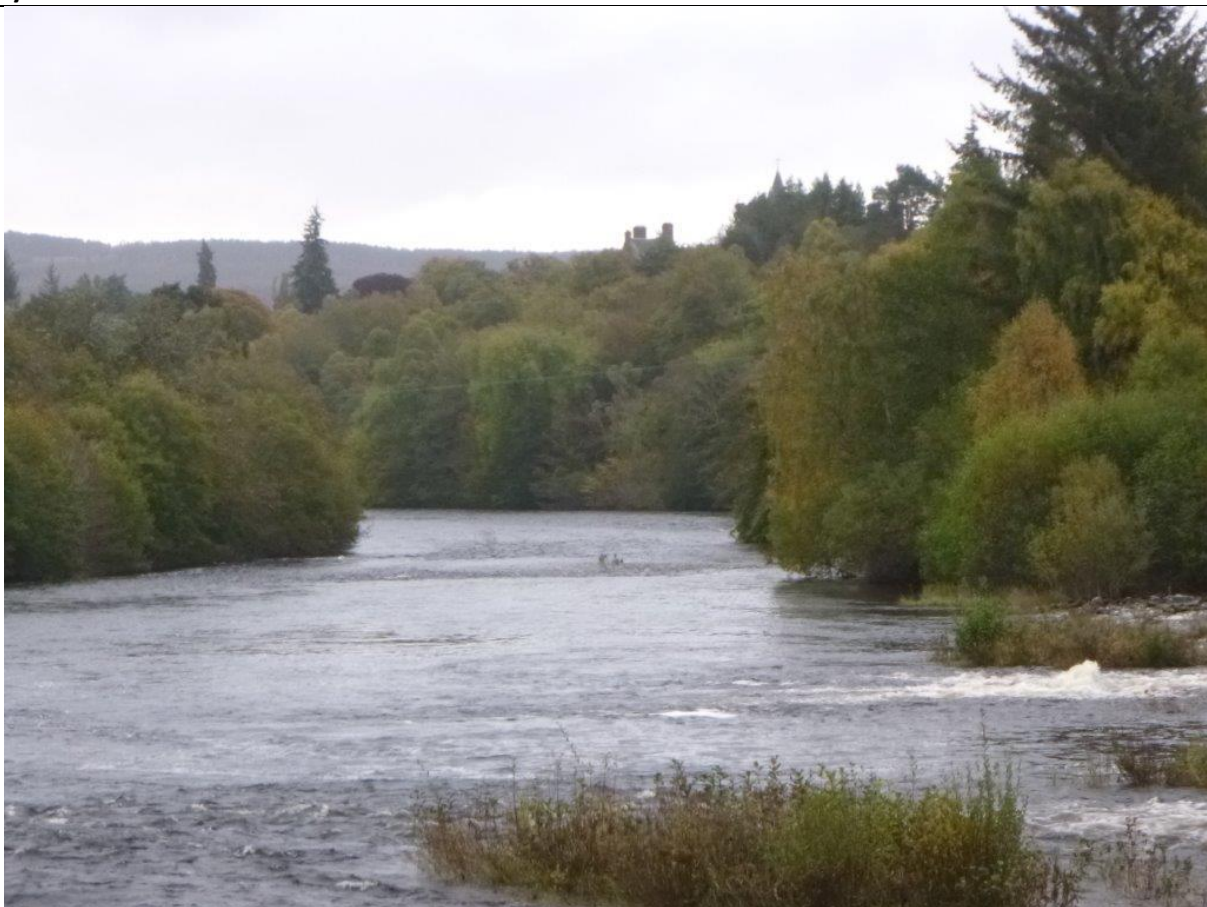
6) Downstream of Cruives, looking to Beaufort castle, Red bridge washed away. NH50134 43430. Higher flow. Pebble/gravel bars not present during walkover (section B26), now predominantly compacted cobble with macrophytes.

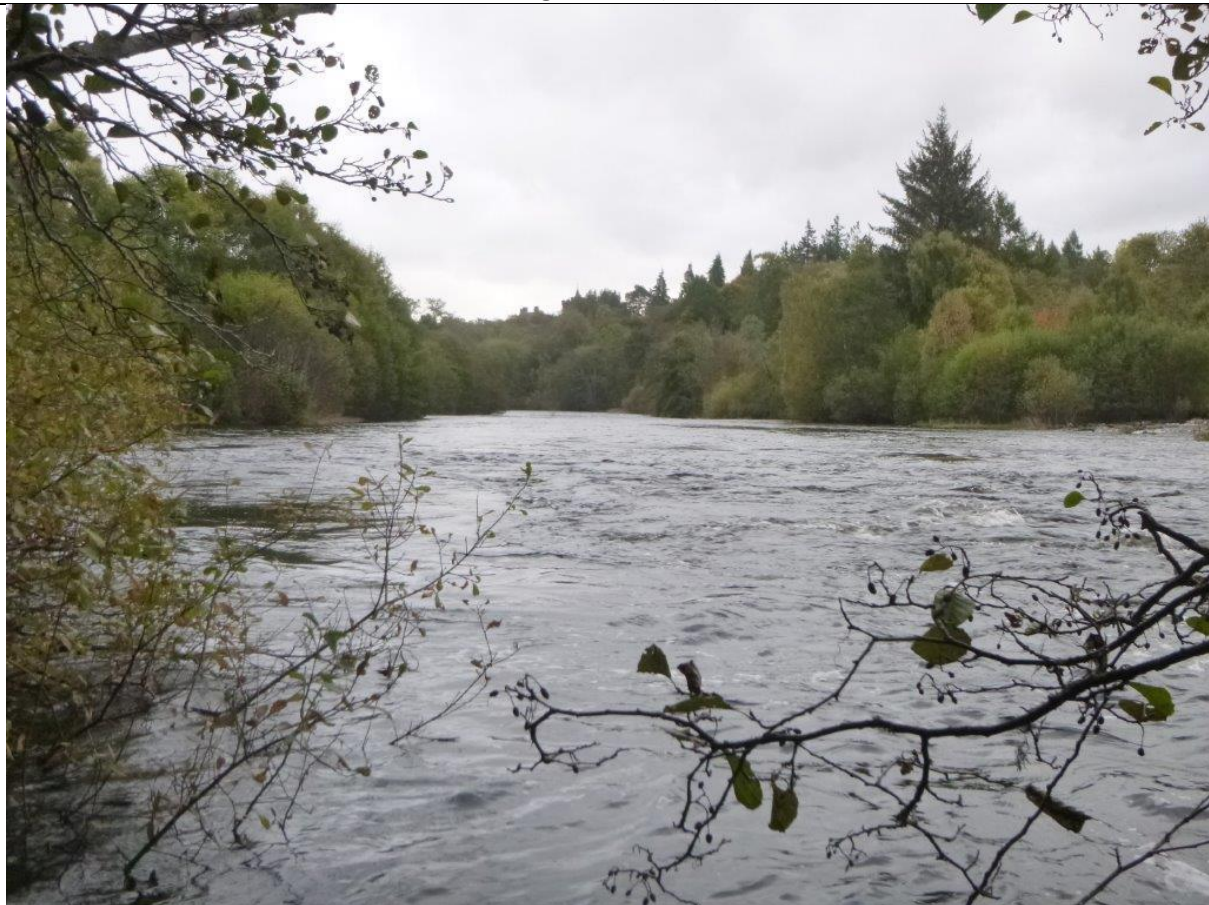
**7)Downstream of Cruives, looking to Beaufort castle and where Red bridge used to be. NH50202 43422. 19/10/23. Higher flow. Walkover shows this substrate is no-longer there (B26).**

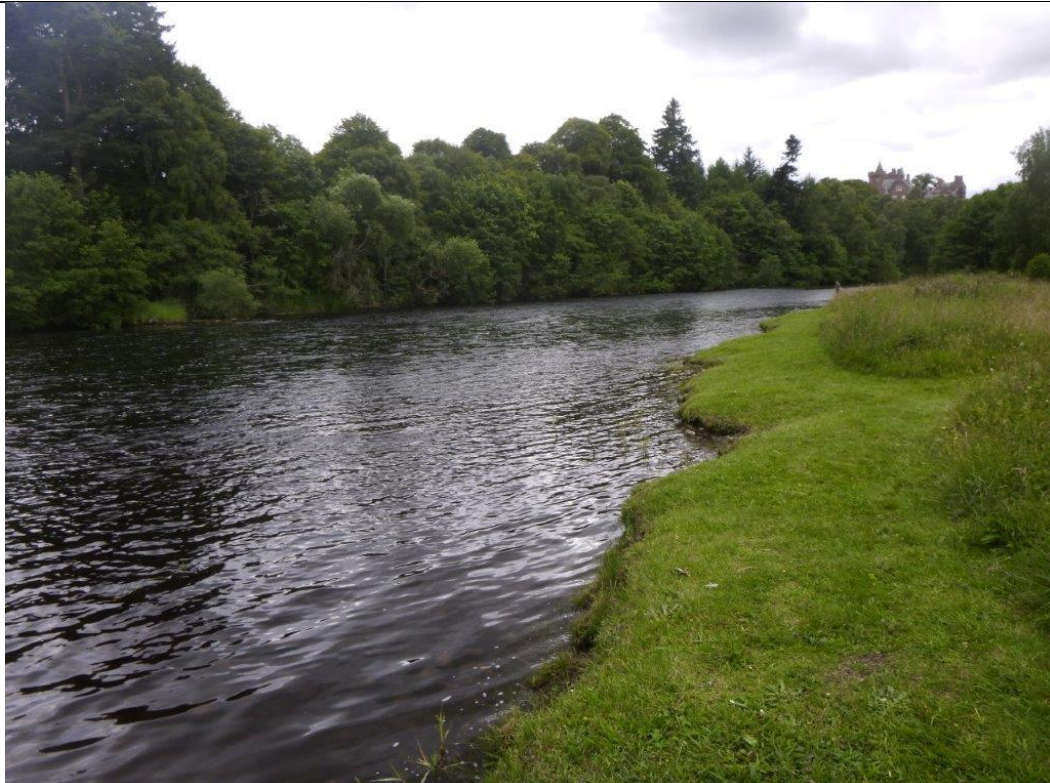
**8) Downstream of Beaufort castle, looking up to Belladrum burn and Beaufort. Photo taken during walkover from further downstream at NH50921 43384 (B27) 12/07/23. Higher flow. Bank is now fully vegetated, and in a defined channel.**
