FARRAR HYDROMORPHOLOGY REPORT 2023

Report prepared by Ruth Watts, Senior Biologist

DRAFT 23/10/2023

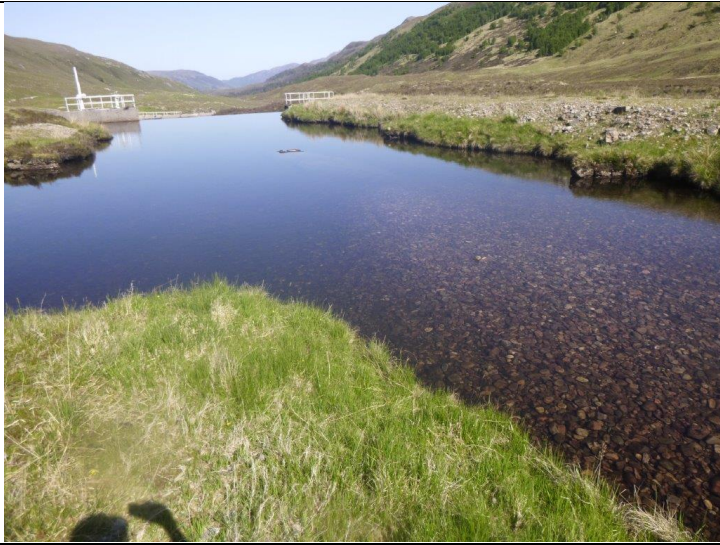
- **at the first Intake.** Suitable spawning sized substrate is held up here, whereas it could be introduced below the spout to become useful spawning substrate in the U. Misge). See [Photo 1](#).

Photo 1: Mixed substrate, unutilised, at the 'first intake' NH17222 37900

-Improved sediment management of unutilised substrate at various structures and locations above Beannacharan dam for the benefit of fish habitat above Beannacharan dam including; At the topmost intake, at the bottom of the waterfall 160m above the spout, at the spout weir, at the Farrar weir.

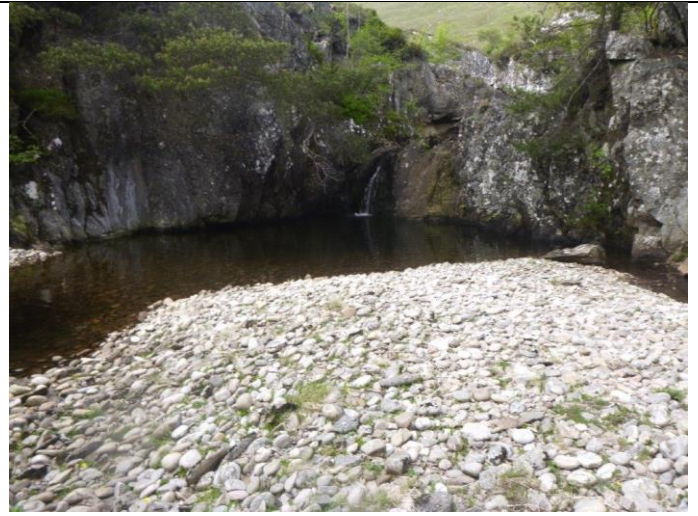
- **at and above the spout weir.** Suitable spawning sized substrate is held up here with limited high flow events to move it over the weir. There is also a pile of suitably sized spawning substrate c160m above the spout at the bottom of the waterfall which is thought to be the natural limit to migration ([Photo 2](#)). This substrate is currently unlikely to be utilised due to the consistently low flows of the abstracted reach immediately above the spout. If more actively managed, and moved downstream of the weir it could be used by fish on the U. Misge. Patches of uncompacted spawning substrate were found in the first 250m downstream of the spout (F30), however partial compaction was observed below there (F32-F34, F39) which may indicate that **the introduction of occasional extreme flood events (in addition to the annual maintenance regime) could help keep substrate uncompacted at the top of the U. Misge.**

Photo 2: Mixed substrate, unutilised at the Natural limit to migration, 160m upstream of the spout. NH18150 37955.

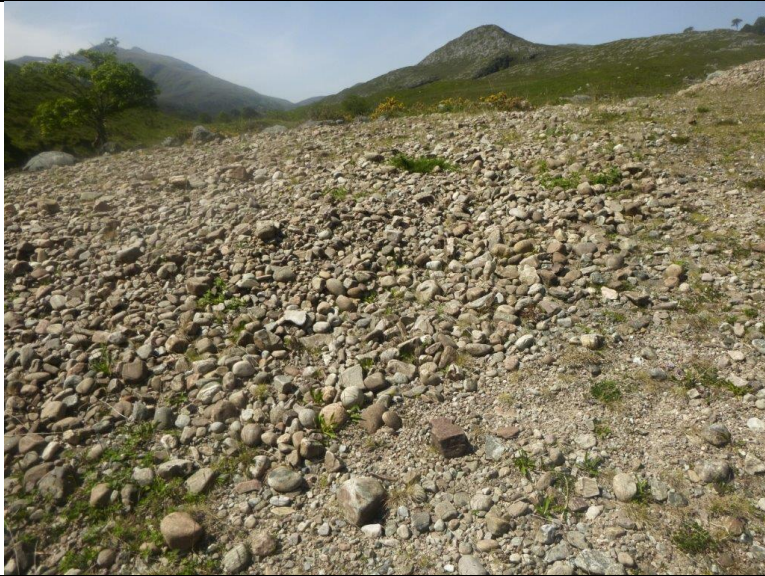
-**above the Farrar weir** (Garbh Usige gauging weir). Historical sediment management appeared to have taken place, however the suitably sized spawning substrate appeared to have been left above the weir on the bank rather than been placed downstream of the weir where it could have been useful ([Photo 3](#)). Over-stability, a predominance of boulders and a lack of spawning substrate defined F48-F53 and these sections could clearly benefit from a better sediment supply. The precise effectiveness will depend on the gradient of these sections which is not assessed in this report. The proportion of spawning substrate picked up from F55-F58 (from the islands at Braulen cottage where the Allt Innis a' Mhuilt comes in, to in front of Braulen lodge, with some active erosion occurring and a change of typology from Plane bed and Plane-riffle to Meandering). The Allt Innis a' Mhuilt and Allt Feithe Baine are providing important spawning substrate to the mainstem river.

Photo 3: Pile of managed substrate placed out of the active channel, upstream of the Farrar weir. NH22102 38915

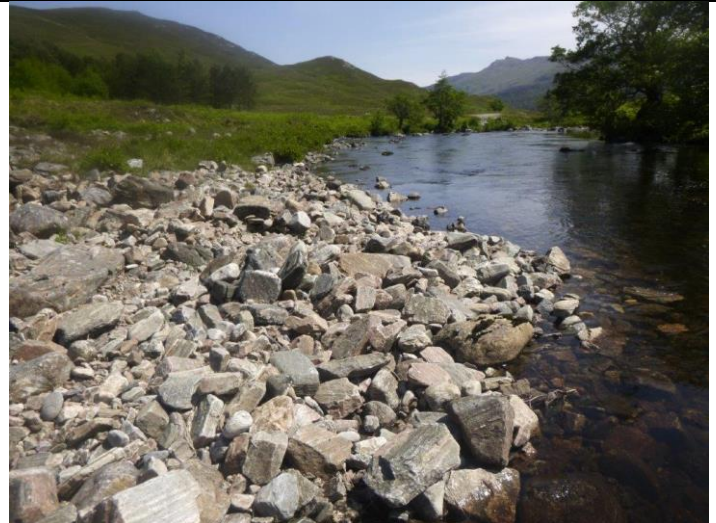
Photo 4: Alluvial fan of the Allt Toll a' Mhuic. NH22500 39102

-Several tapped tributaries were observed to be dry during the course of the walkover and were observed to provide some but overall limited substrate to the mainstem. E.g. the **Allt Toll a' Mhuic** (F50, [Photo 4](#)) and **the Allt Uchd Rodha** (F64).

The Allt Toll a' Mhuic is within sections F48-F53 highlighted as having stable conditions with predominantly cobble-boulder substrate, therefore any improvement to the flows and sediment management on this burn could prove beneficial to the mainstem, by increasing the amount of pebble-gravel in these sections.

-Improved sediment management (with introduction of more frequent high flow events) at intake tributaries particularly at the top of the U. Misge, the Allt Toll a' Mhuic, Allt Uchd Rodha. and Allt Coire Mhuilidh to enable transport of pebble-gravel substrate down to the mainstem.

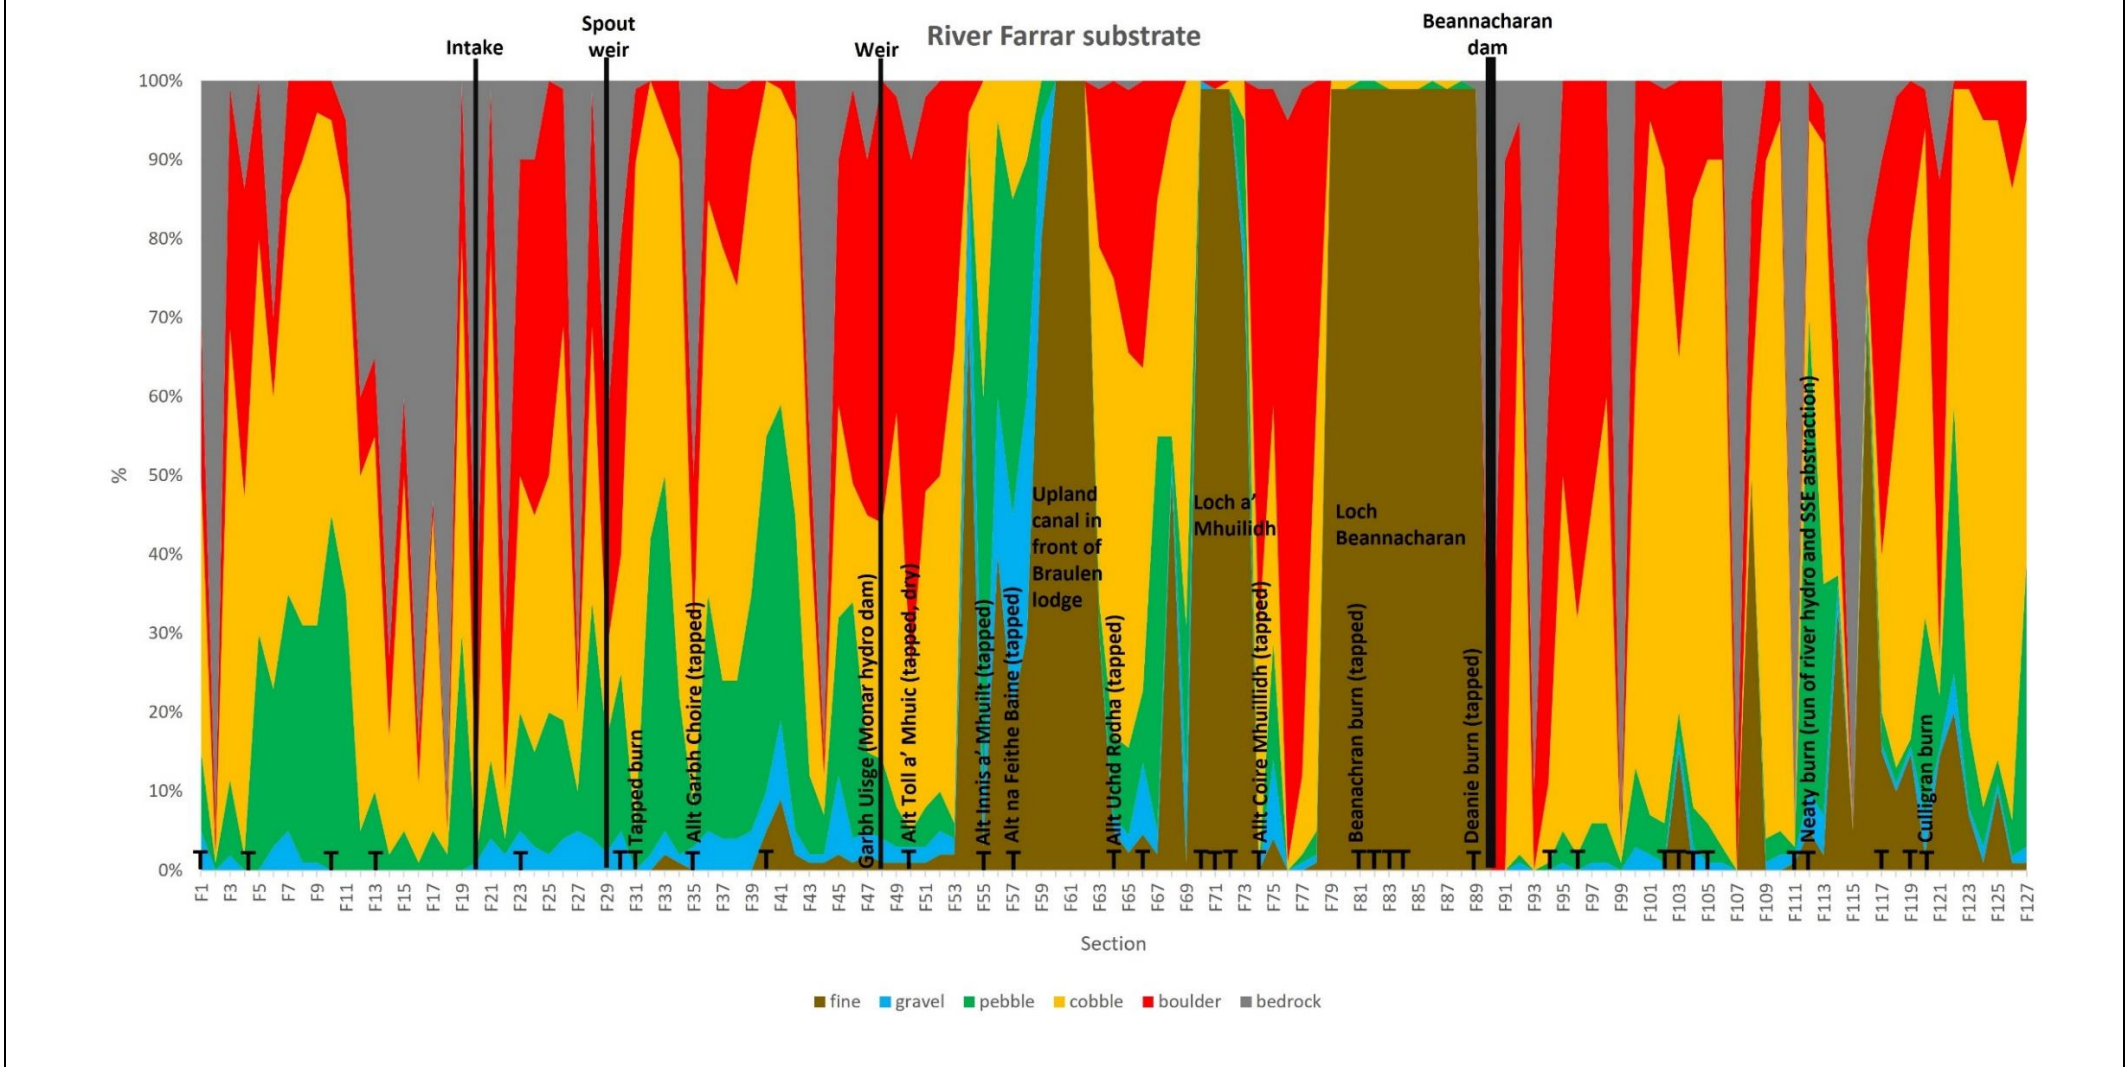
Figure 1: Percentage of substrate for each section, with annotation. T= Tributary providing substrate to the mainstem.

There is clearly a lack of gravel and pebble substrate below the dam when compared to above the dam. The proportion of cobble substrate is similar above and below.

Despite being 'tapped', the intake burns above Beannacharan dam appear to be providing gravel and pebble substrate to the mainstem, so it would appear that annual maintenance at the intakes is allowing substrate to move down the tributaries, however it is not clear what the current regime is and if this could be refined further to increase the amount of spawning substrate available to adult salmon.

Neaty and Culligran burns appear to be key substrate providers below Beannacharan dam.

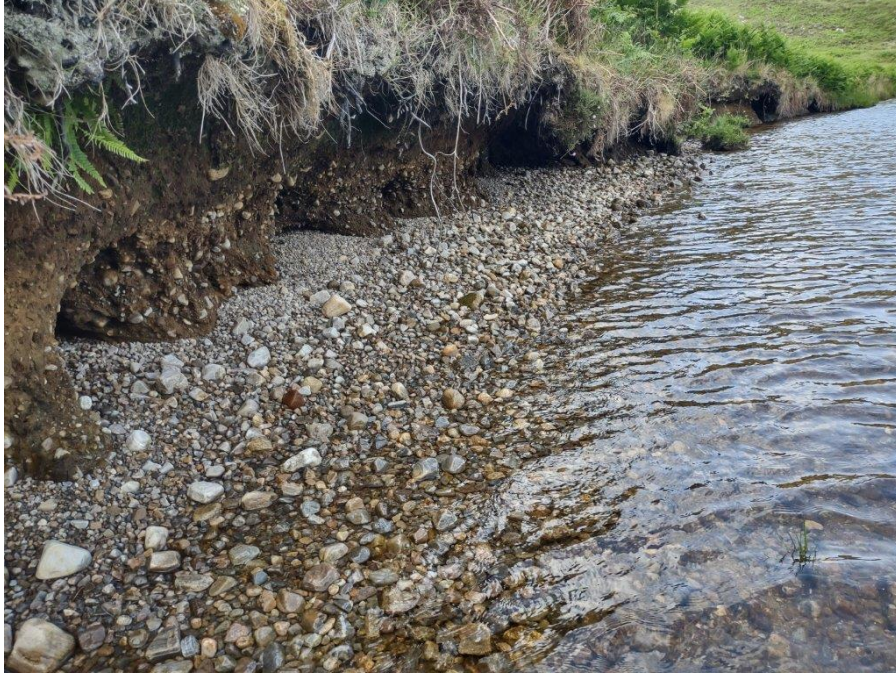
-The north shore of Loch Beannacharan (F81-82) appeared to be actively eroding and pebble substrate was being liberated from the banks into the loch. It is unclear where this useful substrate ends up.

During the walkover, rounded pebble was observed being eroded from the banks of Loch Beannacharan and longitudinal drift processes seemed to be at work ([Photo 5](#)). This would imply that the final resting place for substrate above the dam is in loch Beannacharan itself but a large pile of pebble/ gravel substrate was not directly observed due to the depth of the loch.

Photo 5: Active erosion providing substrate along the N bank of Loch Beannacharan (F81) Photo IMG_20230621_161728602_HDR

-The introduction of sediment management and improved flow regime at Beannacharan dam (and Culligran power station) to halt or reverse the decline in spawning substrate availability downstream of the dam is strongly recommended. As useful substrate is likely being held up in Loch Beannacharan above the dam (precise location unclear), it is recommended that suitable alluvium deposits are won from borrow-pits on either Braulen or Culligran estates (or the nearby Breedon aggregates quarry) and introduced into the river downstream of the dam. This would be in consultation with SEPA, SSE and in line with best practice sediment management guidance. During the walkover rounded pebble was observed being eroded from the banks of Loch Beannacharan and so appears to be locally available.

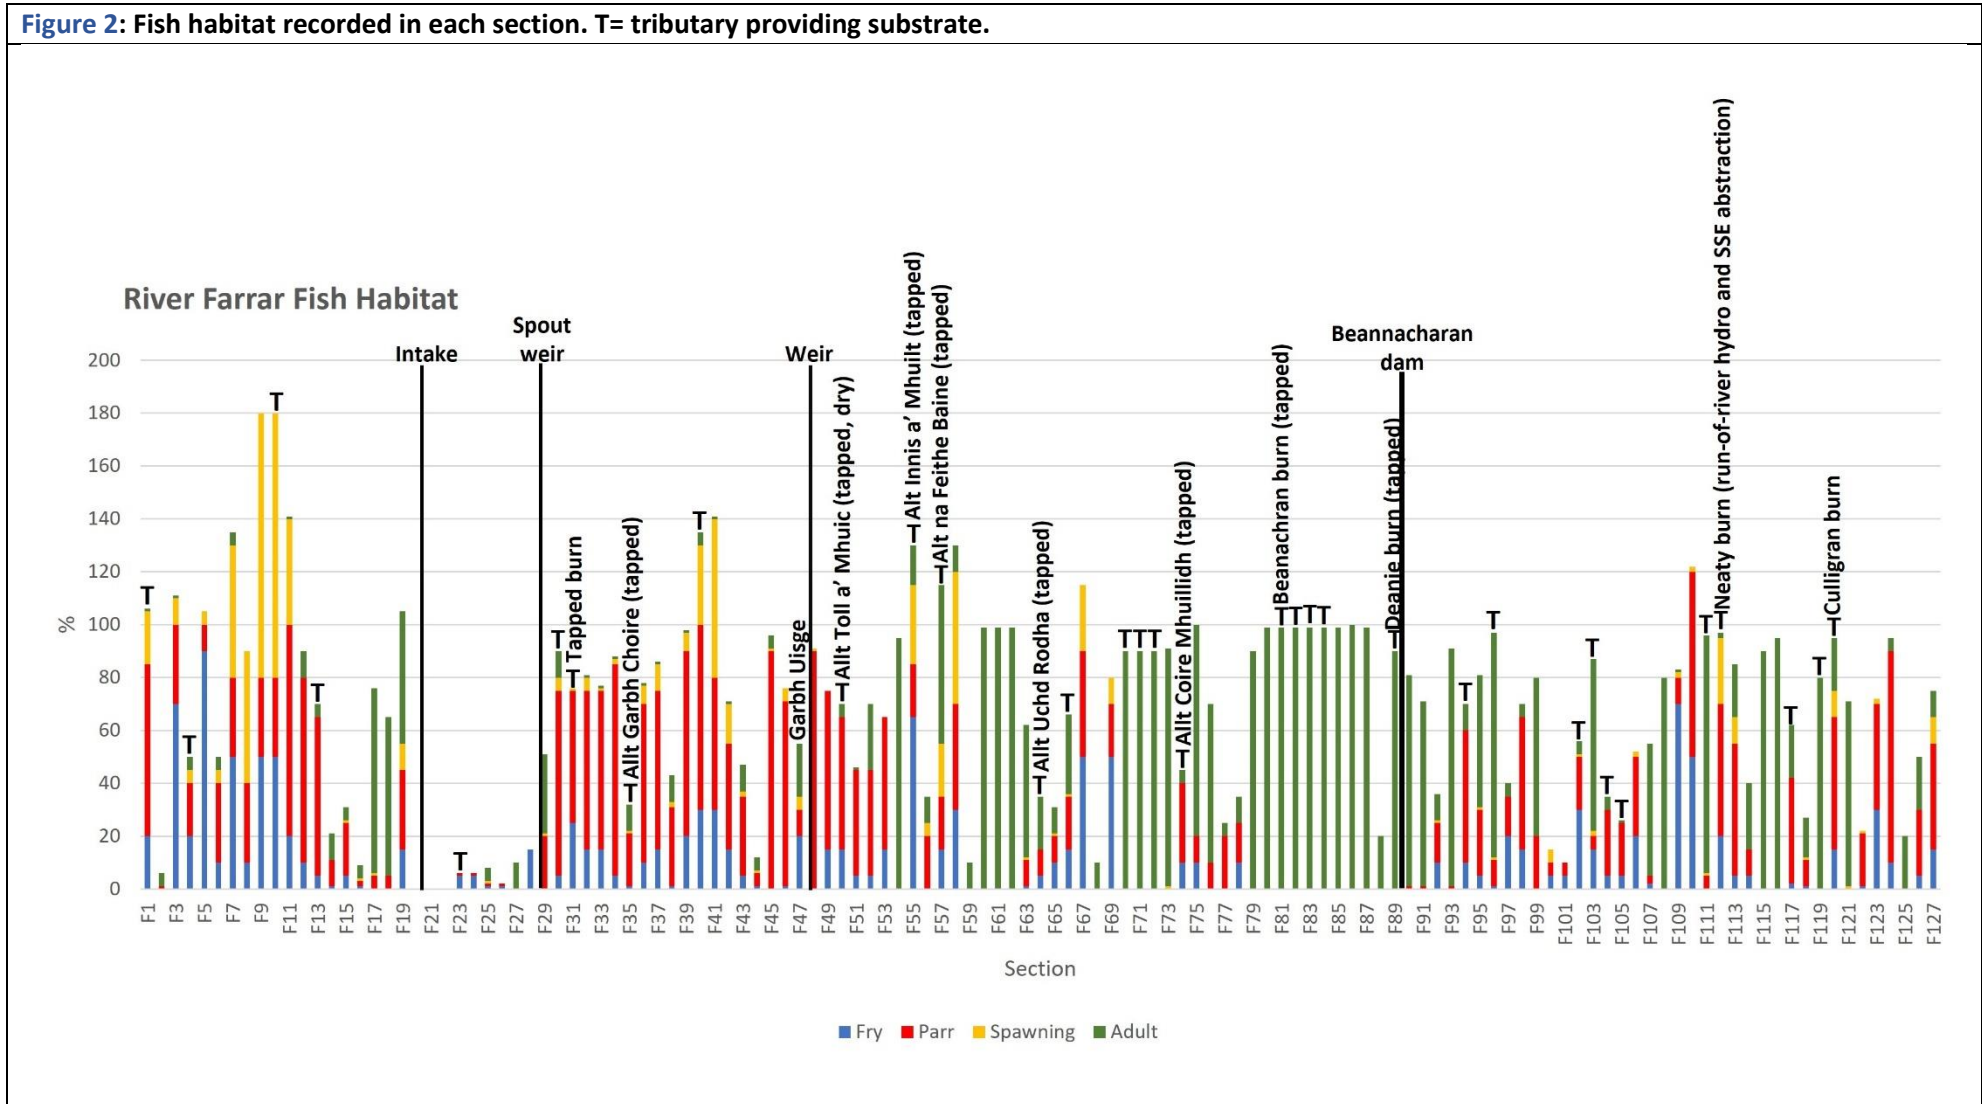
Figure 2: Fish habitat recorded in each section. T= tributary providing substrate.

There appears to be relatively less spawning habitat available to adult salmon downstream of Beannacharan dam compared to above.

-That there is a relative lack of spawning habitat in sections F91-F111 (Beannacharan dam-Neaty burn), despite the typologies in most of these sections suggesting that the gradient could host spawning habitat.

-A lack of spate flows and compaction on the lower Farrar is likely to be limiting the quality of spawning habitat.

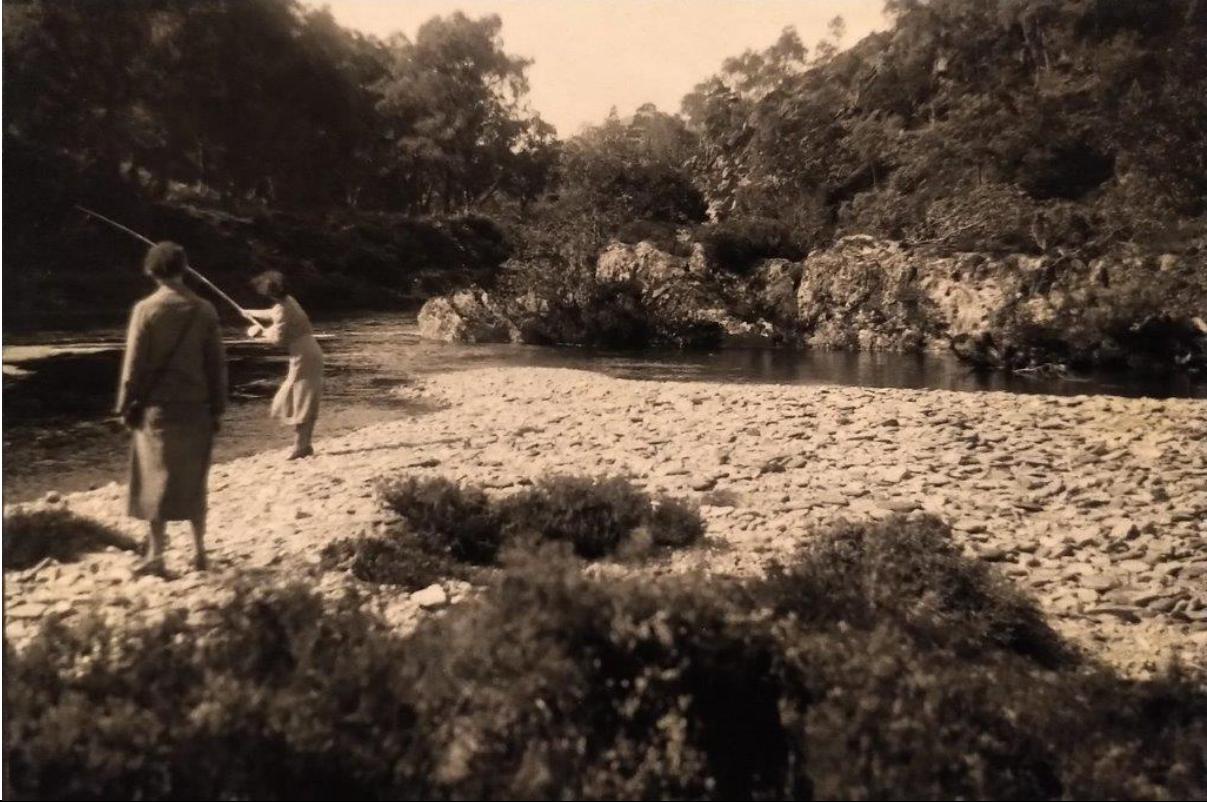
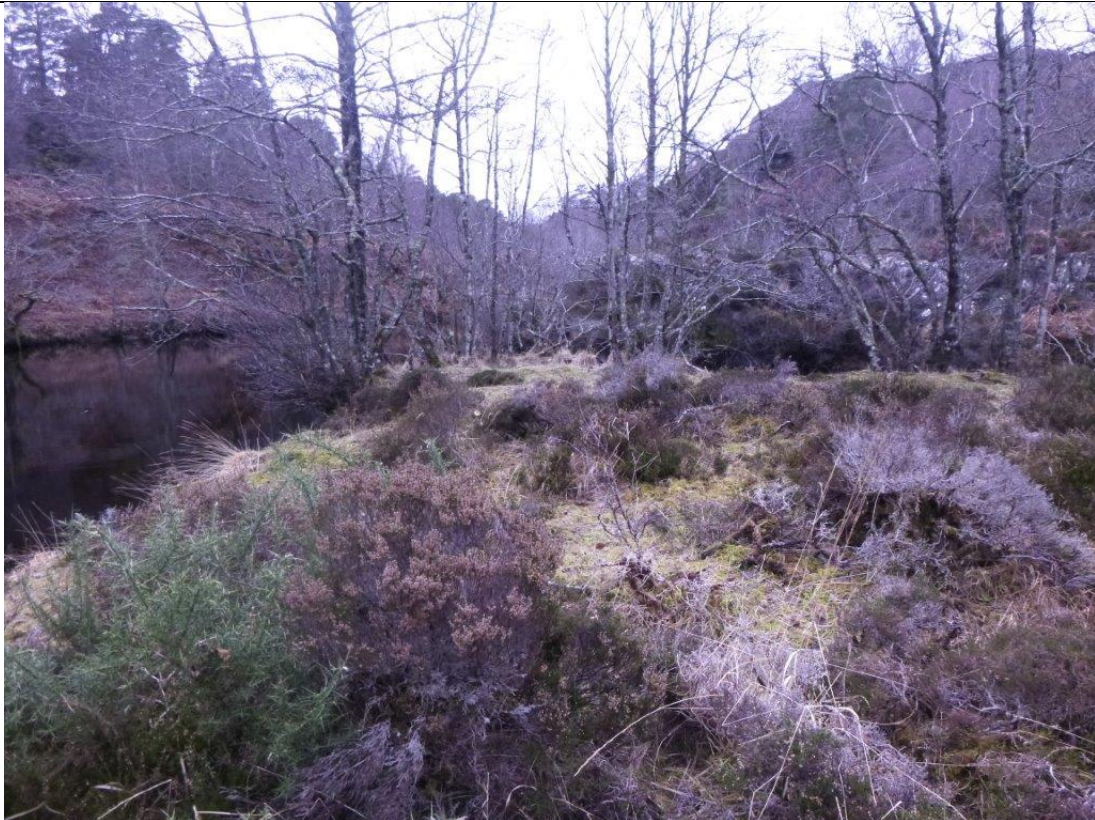
1) NH33613 39494 Ross's pool PRE. Mobile substrate bar at top of island. Rock face visible.

1) NH33613 39494 Ross's pool POST. Stable vegetated island, no mobile substrate. Channel on right of photo now dry/ vegetated (F97).

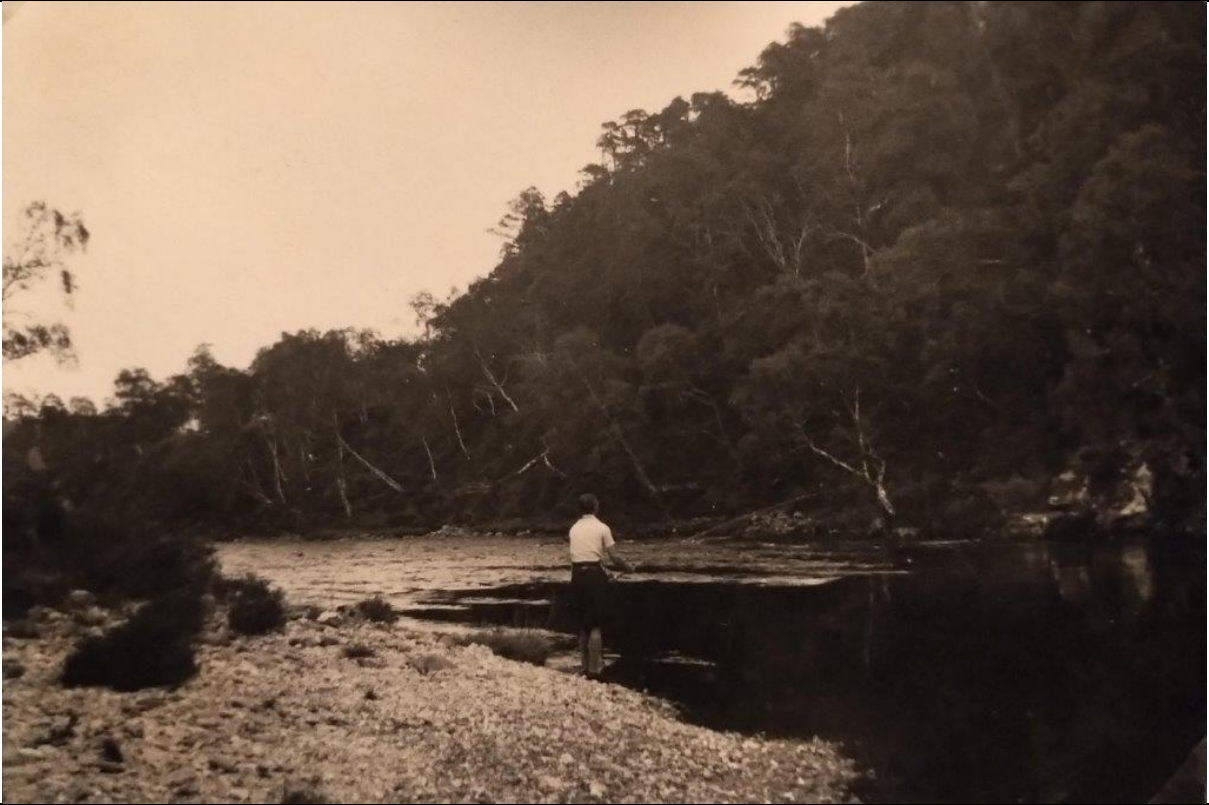
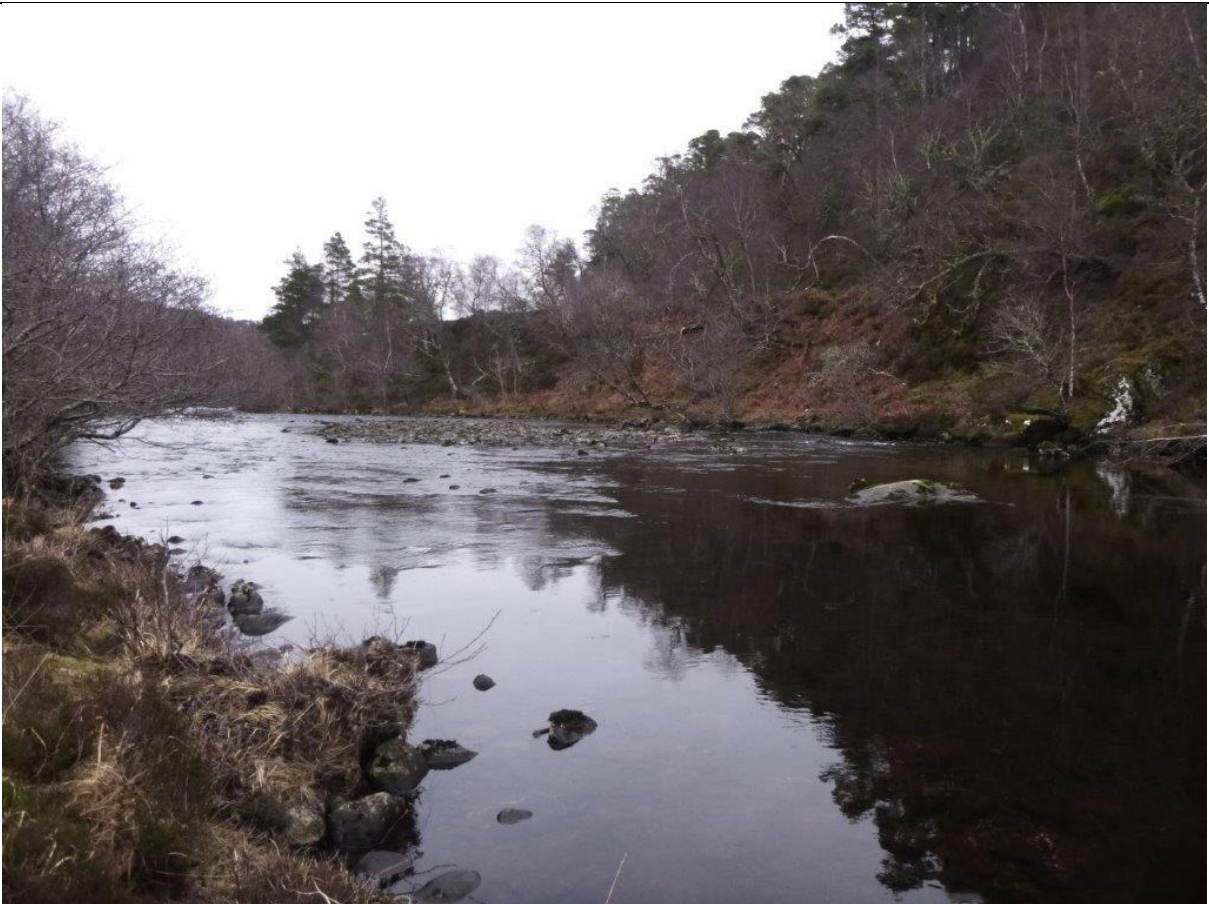
2) NH33648 39476 Ross's pool PRE. Pebble-gravel substrate present along left bank.

2) NH33648 39476 Ross's pool POST. Higher water level, encroaching bank, cobble-boulder (F97).

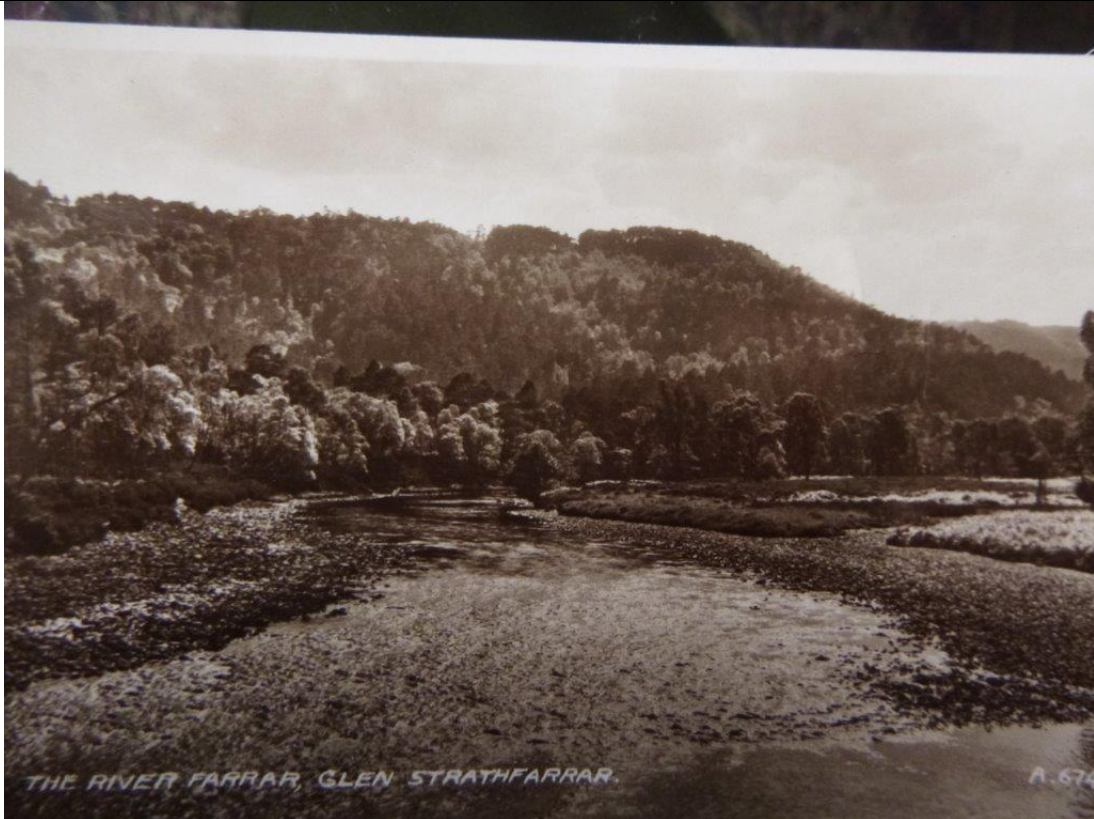
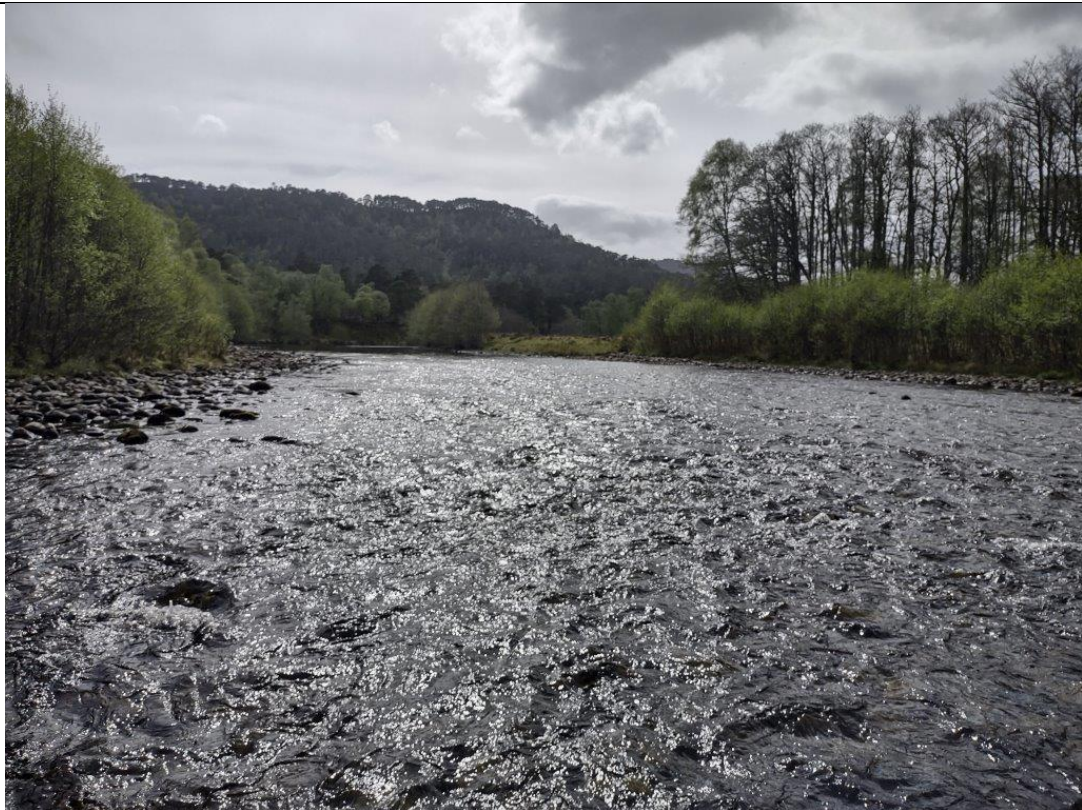
3) NH34573 39725 Little Bridges, FAR2 efish site PRE. Richard Wood's postcard. Mobile gravel and pebble side bars along both banks.

3) NH34573 39725 Little Bridges, Far2 efish site POST. Higher water level. Predominantly cobble substrate and encroaching banks with trees due to stable flow regime (F102).

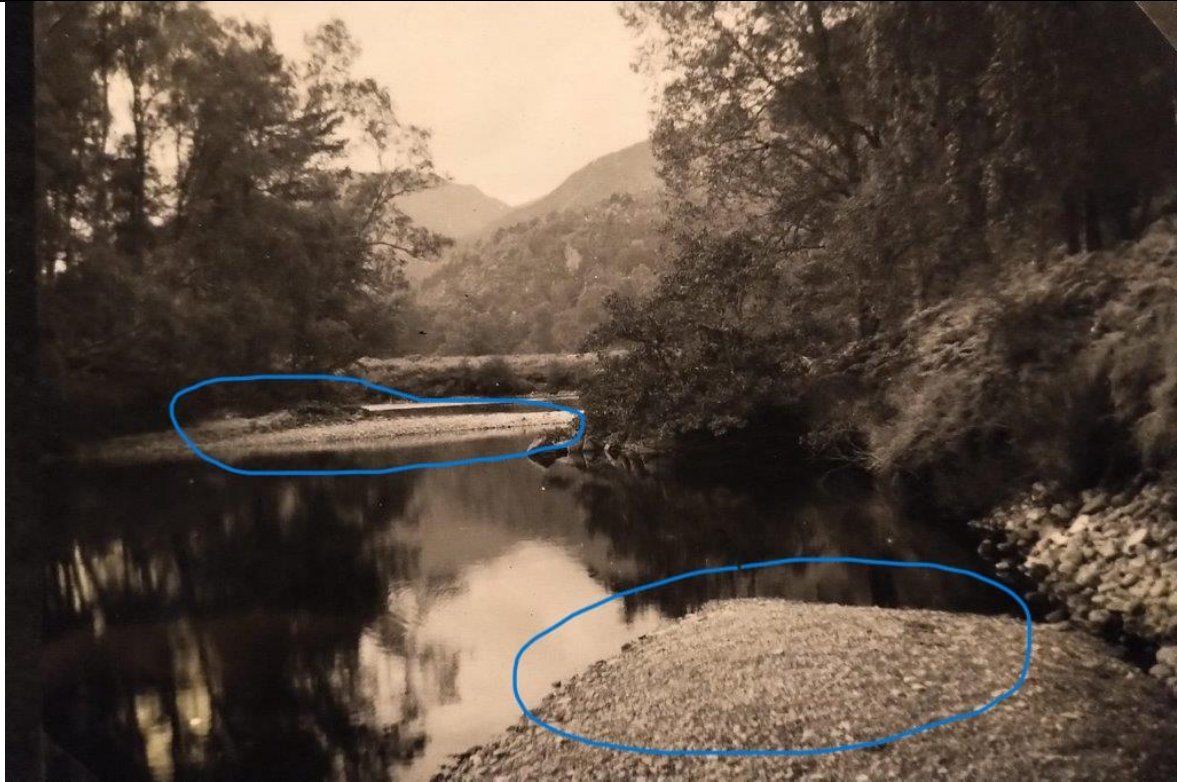
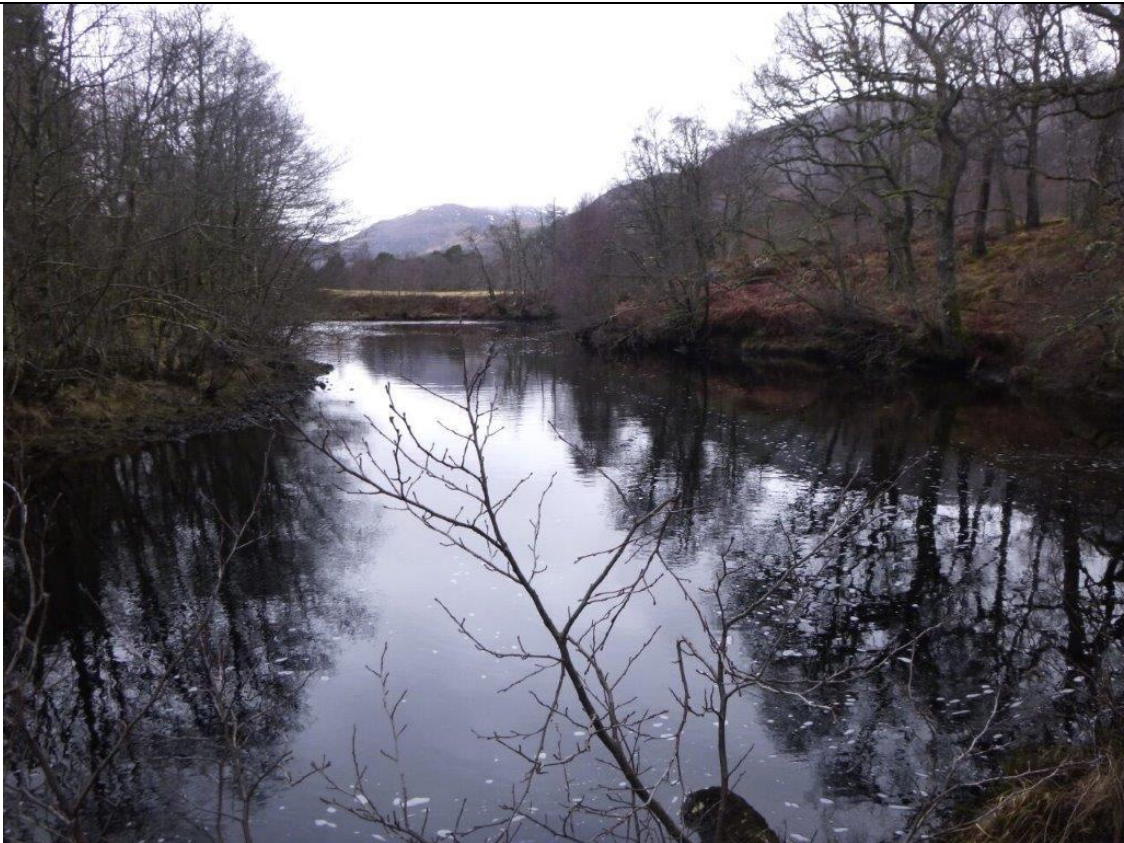
4) NH35072 39479 Fir tree PRE. Gravel bars.

4) NH35072 39479 Fir Tree POST. Higher water level. Missing gravel bars (photo taken stood on overgrown bar). F103.

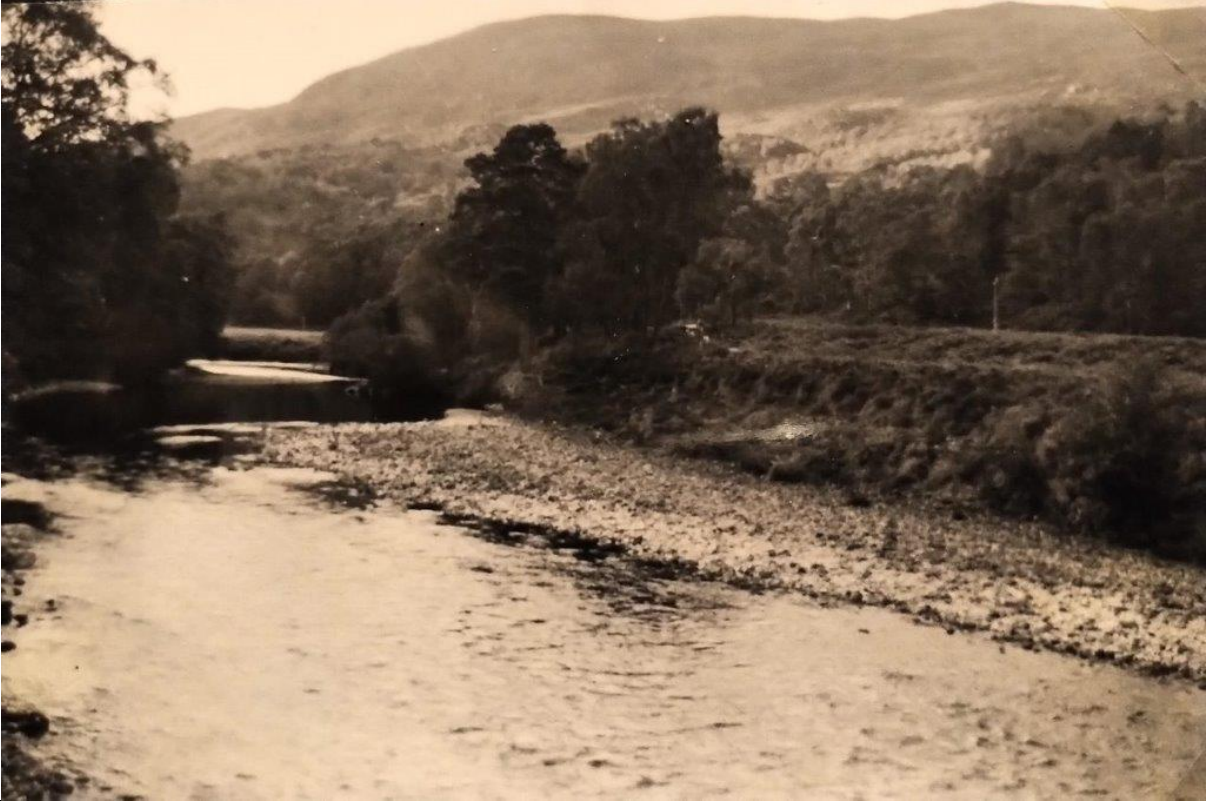
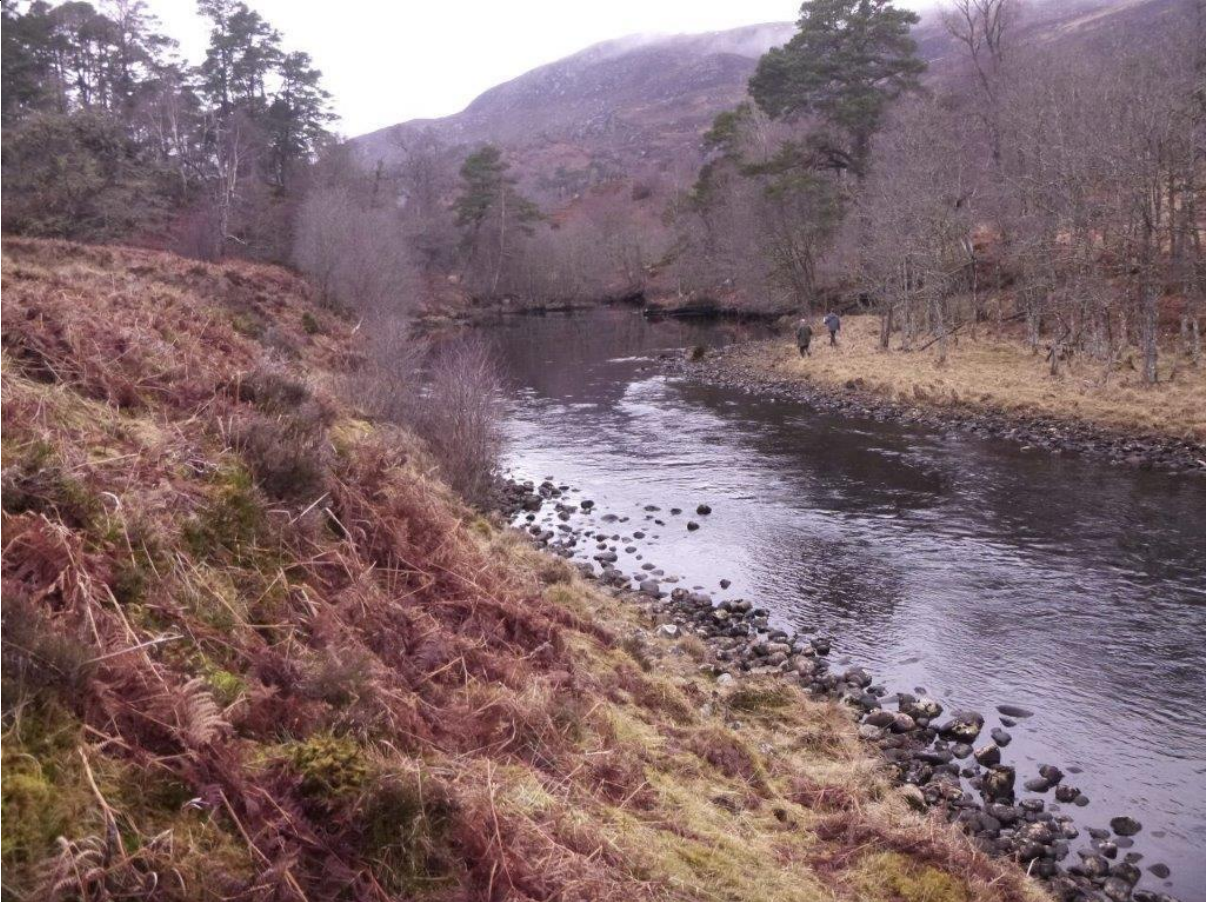
5) NH35306 39363 Cooper's bridge PRE. Exposed mixed substrate sidebar.

5) NH35306 39363 Cooper's bridge POST. Now vegetated cobble bar. (F104).

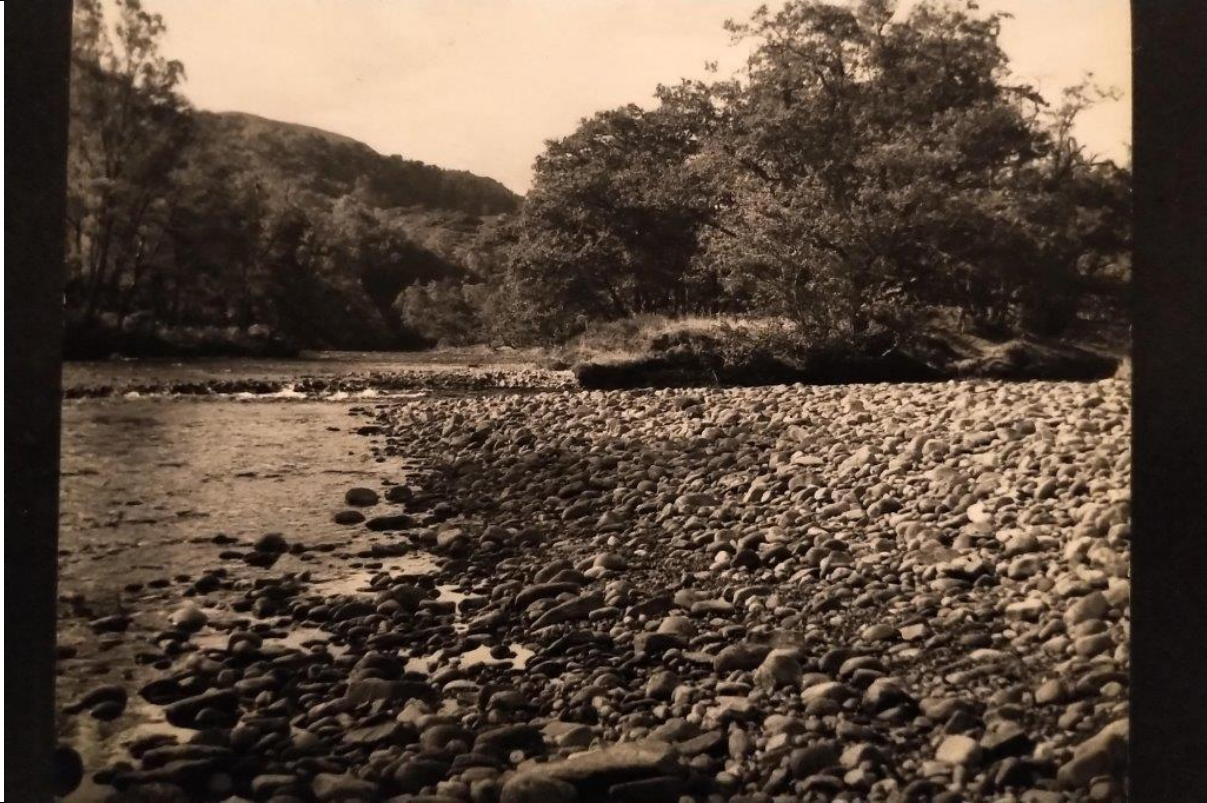
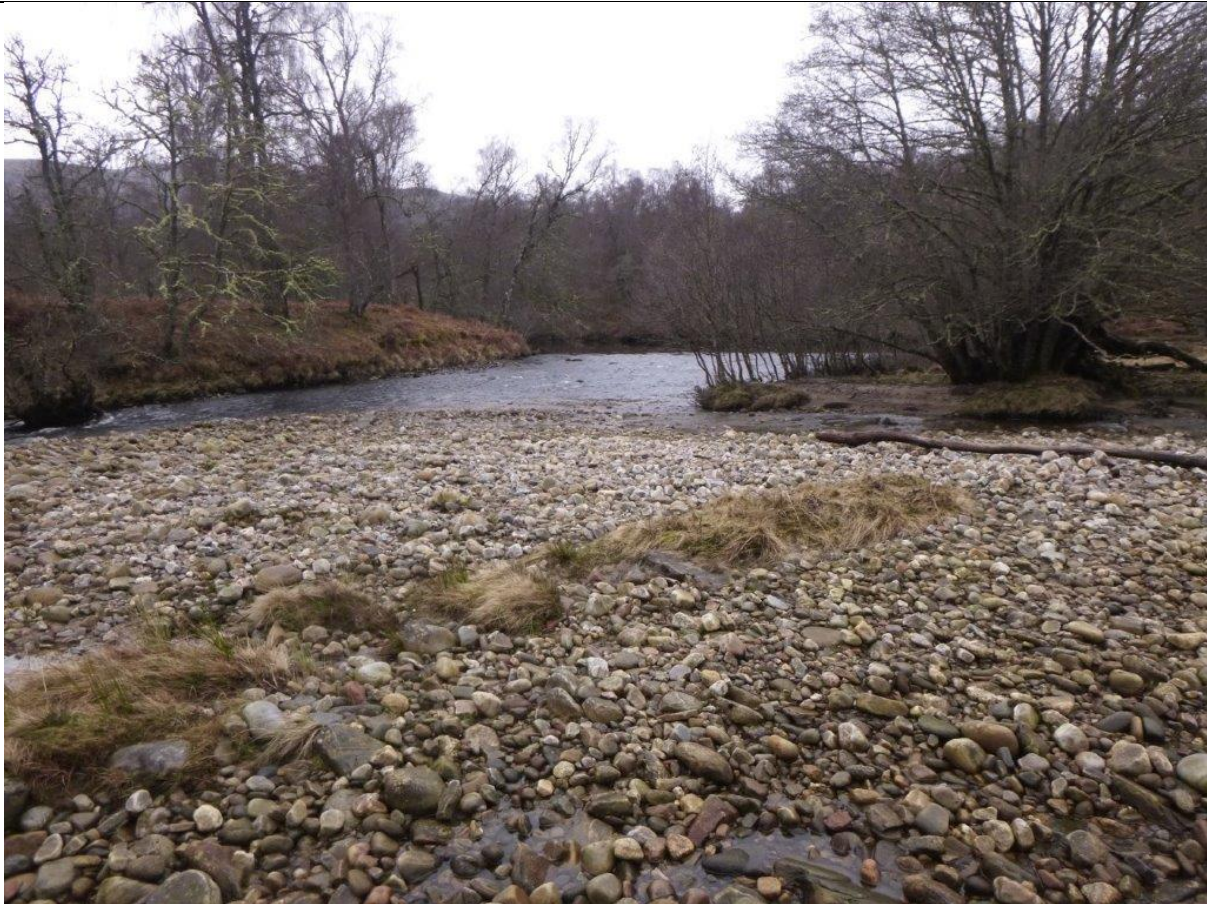
6) NH37307 39724 Neaty alluvial fan PRE. A mix of substrate.

6) NH37307 39724 Neaty alluvial fan POST. Similar then as now (F112).

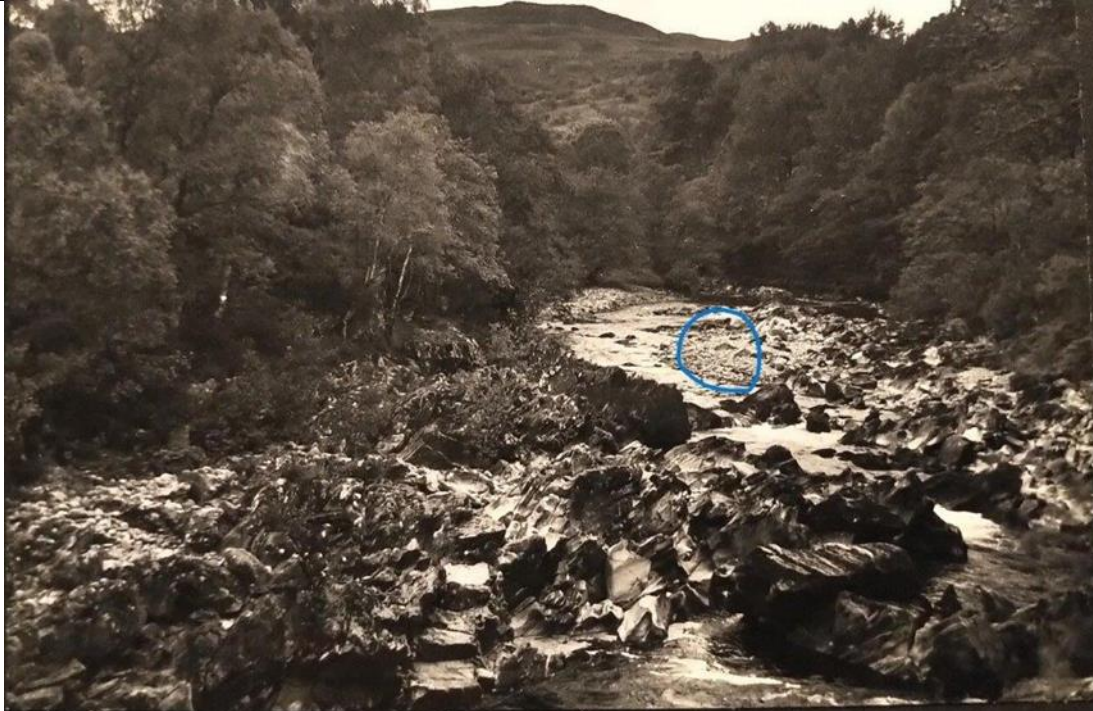
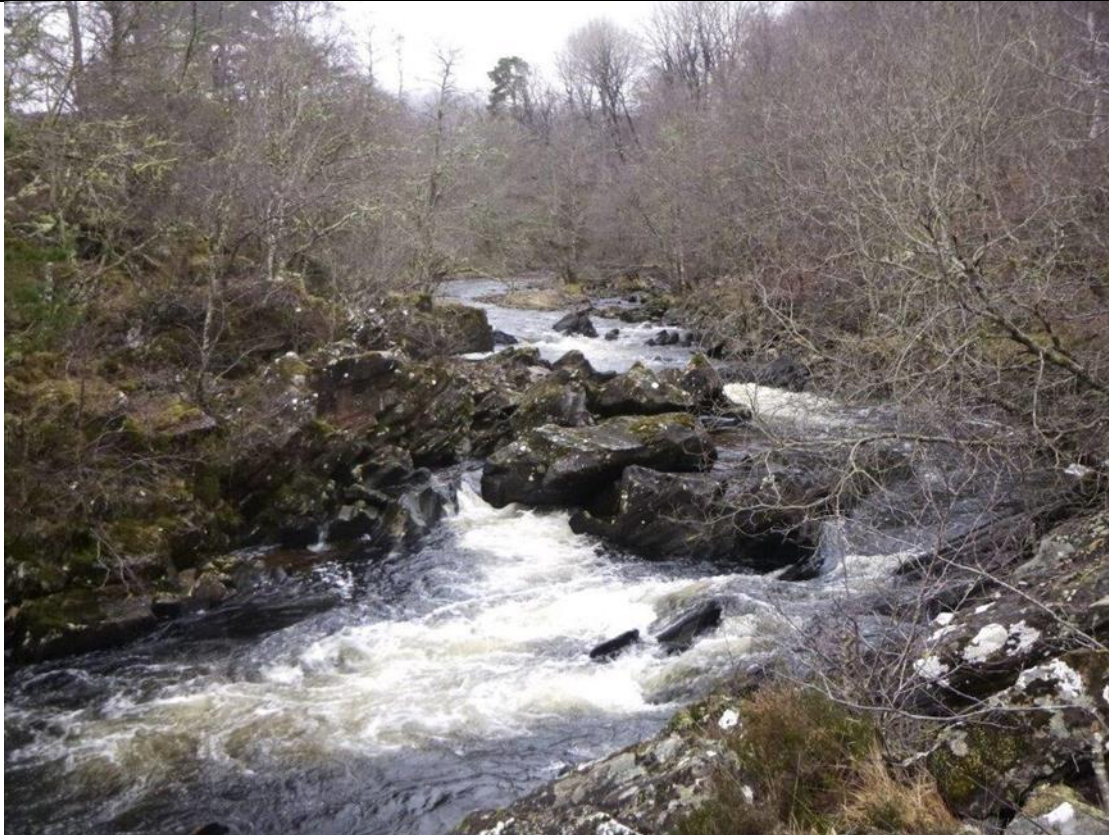
7) NH37701 40050 Above Culligran falls PRE. Cobble bar in background.

7) NH37701 40050 Above Culligran falls POST. Now a vegetated, stable bar (F115).
