FARRAR HYDROMORPHOLOGY REPORT 2023

Report prepared by Ruth Watts, Senior Biologist

DRAFT 23/10/2023

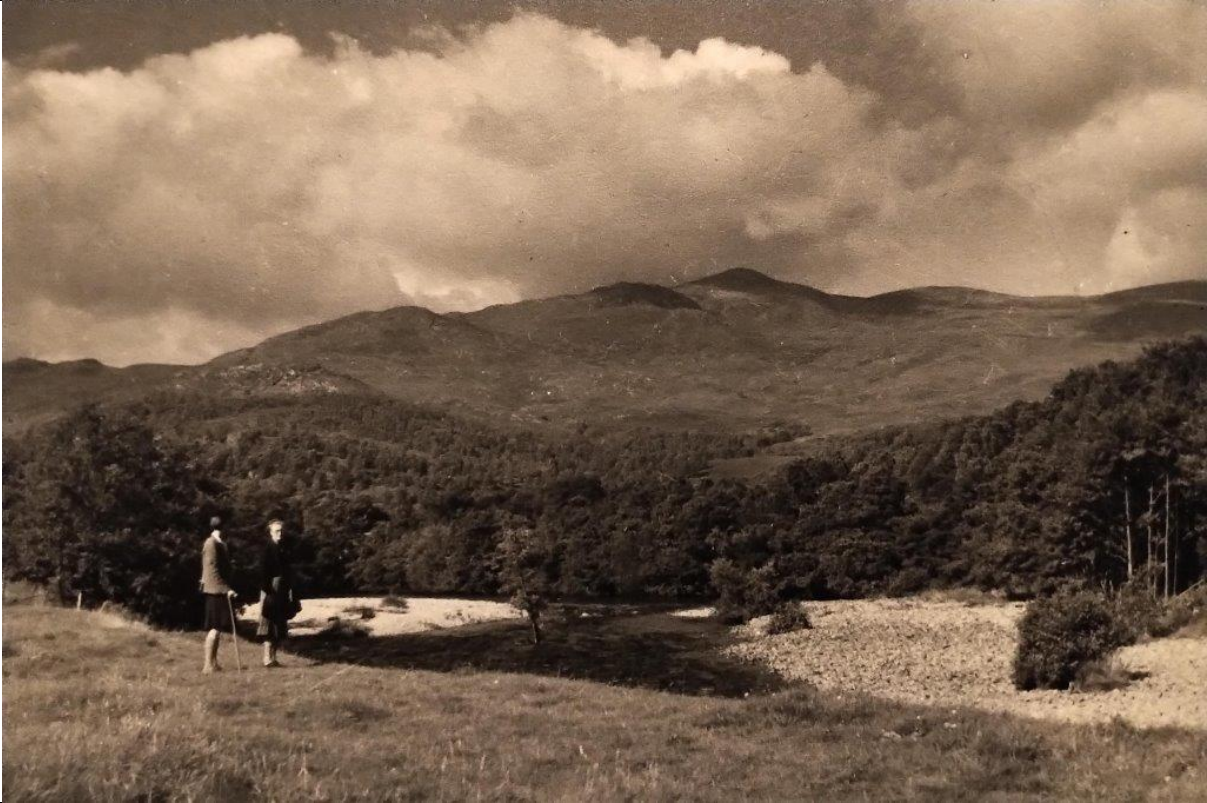
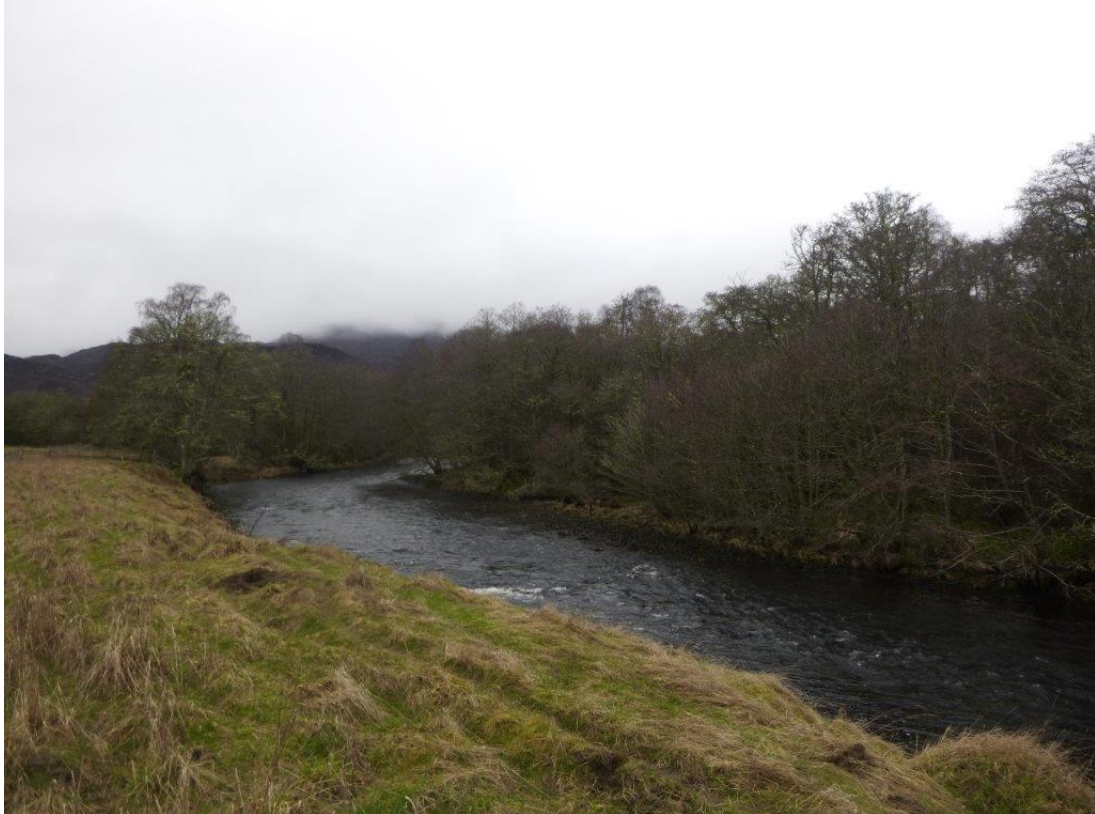
8) NH39649 40434 Looking upstream from above Lodge Pool PRE. Abundance of mobile substrate bars (Meandering-braided typology)

8) NH39649 40434 Looking upstream from above Lodge Pool POST. Mobile gravel bars now treed, stable islands, Plane-riffle typology (F24).

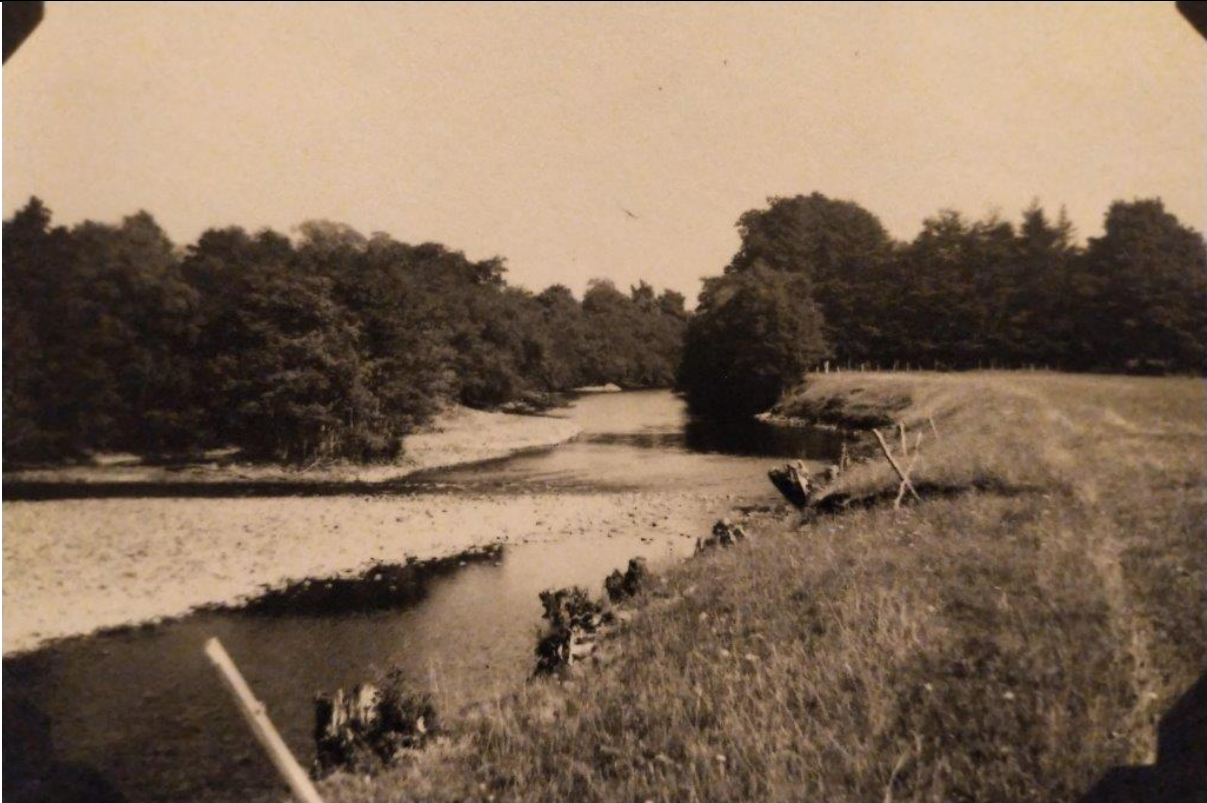
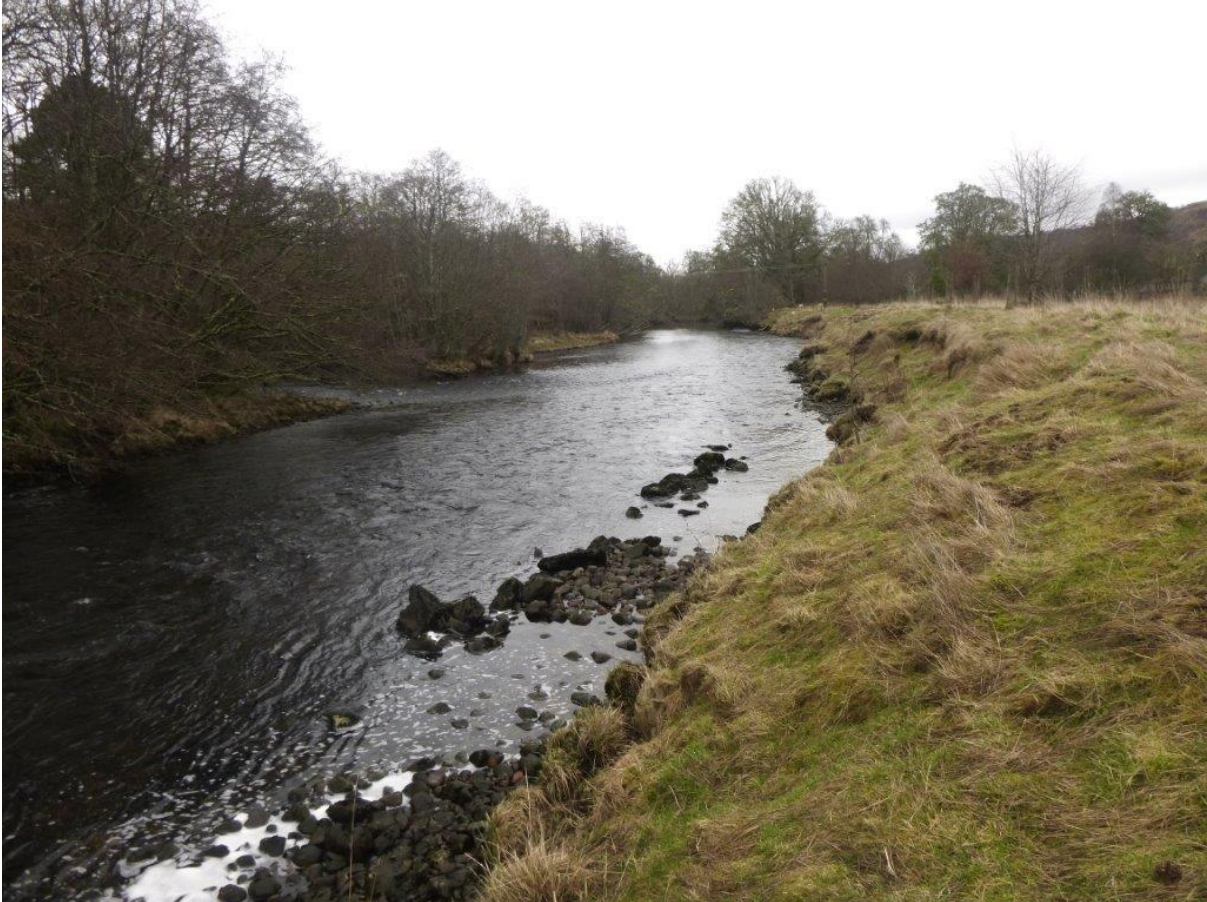
9) NH39574 40468 Above Lodge Pool PRE. Mobile substrate bars.

9) NH39574 40468 Above Lodge Pool POST. Gravel bar now vegetated and stable (F24).
