FARRAR HYDROMORPHOLOGY REPORT 2023

Report prepared by Ruth Watts, Senior Biologist

DRAFT 23/10/2023

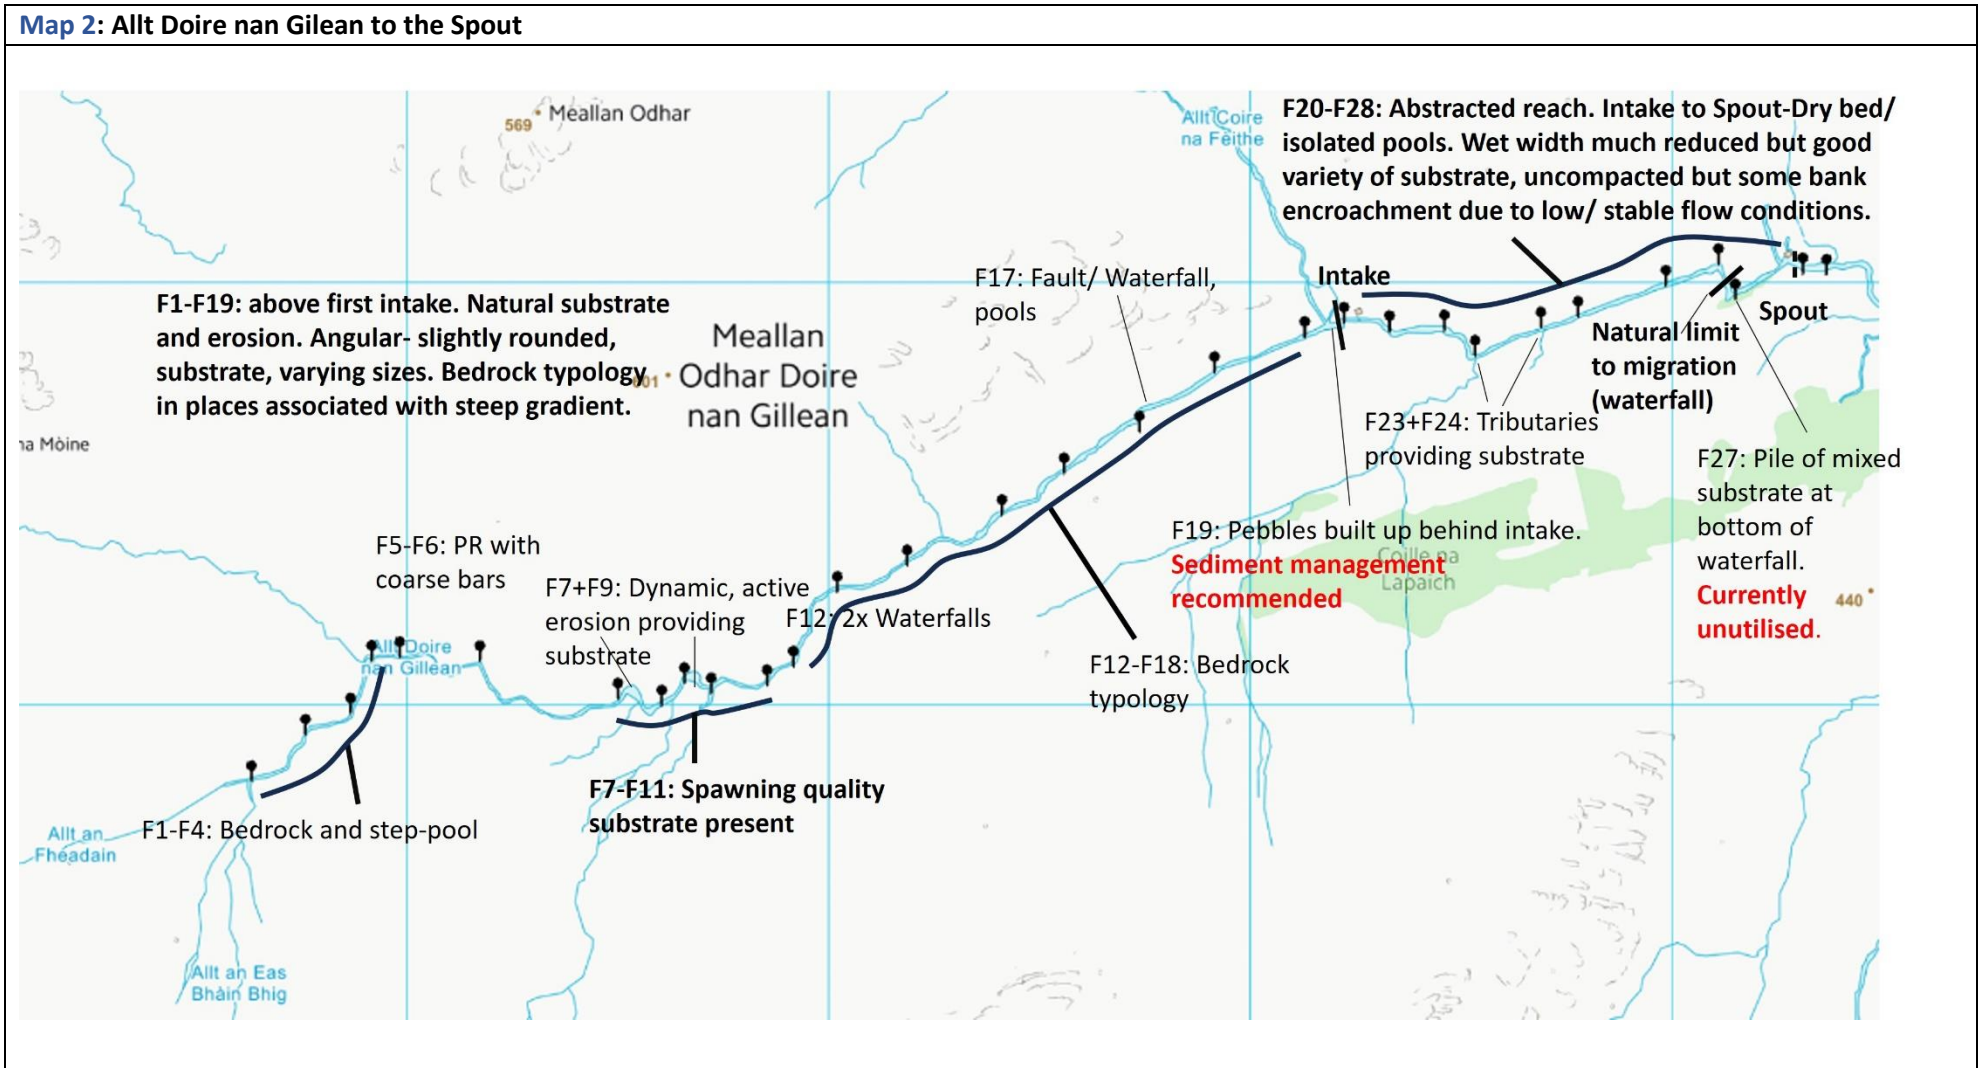
Map 2: Allt Doire nan Gilean to the Spout

Below are the maps summarising the main findings of the walkover surveys for all sections (F1-F127).

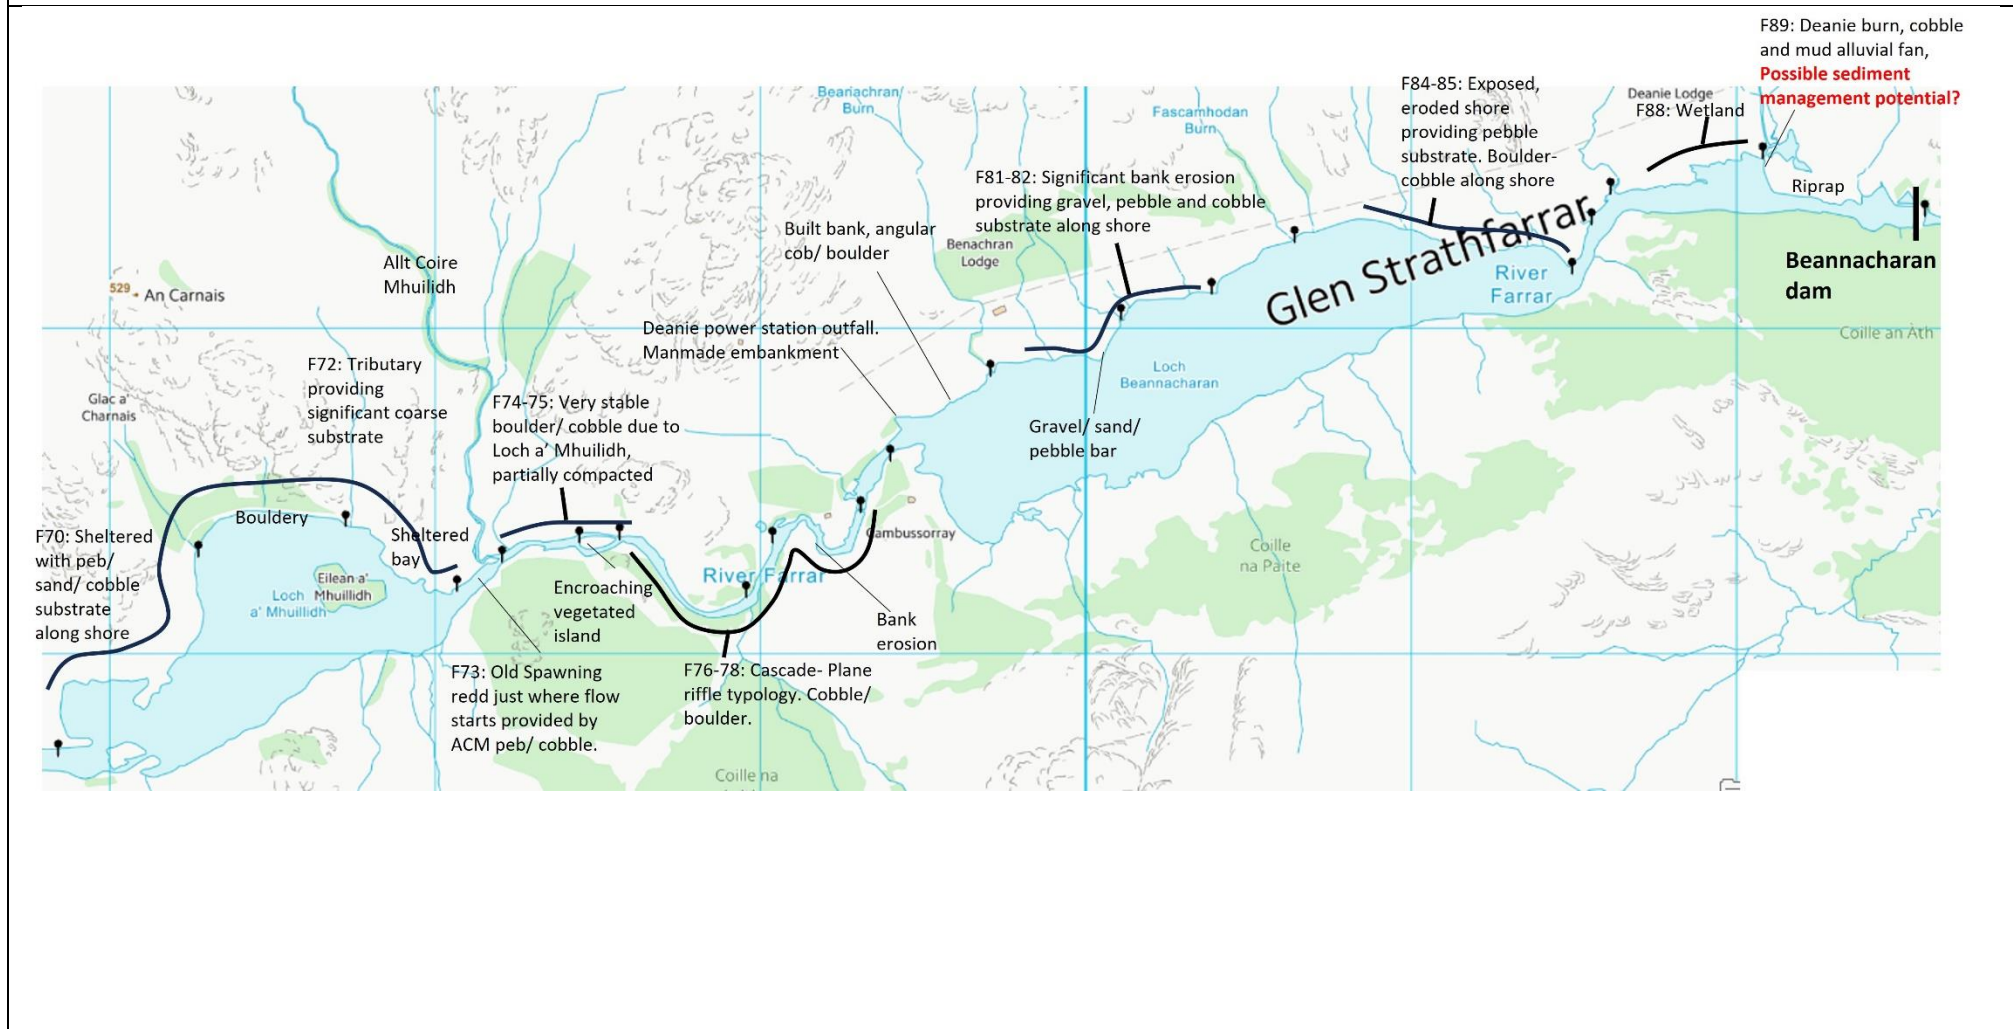
Map 5: Locha Mhuilidh to Beannacharan dam

-possibly at the **Deanie burn alluvial fan** (immediately above Beannacharan dam). The alluvial fan here is under still water (unsuitable conditions for salmon spawning) and so might lend itself to being used in sediment management downstream of Beannacharan dam, however it may be better management practice overall to encourage more flow down this burn to create an attraction flow where the burn meets the loch to encourage fish to spawn in the lower burn instead, as past fish surveys have highlighted a lack of salmon fry in the burn.

-It was observed that Loch a' Mhuilidh appeared to be a substrate sink overall despite there being a tributary on the N shore providing a significant amount of coarse substrate (F72). The presence of the loch appears to be keeping the river below here (F73-75) very stable. This is to the point that encroachment is occurring and the cobble/boulder substrate in F74 is partially compacted. The **Allt Coire Mhuilidh** is potentially a significant substrate source in this section despite it being tapped but there is a lack of spawning habitat downstream of it. The intake is specially designed to allow substrate to pass over it, and the flow regime has apparently been improved to allow more water down the burn but it is unclear how often the burn spates. There could be improvements made here.

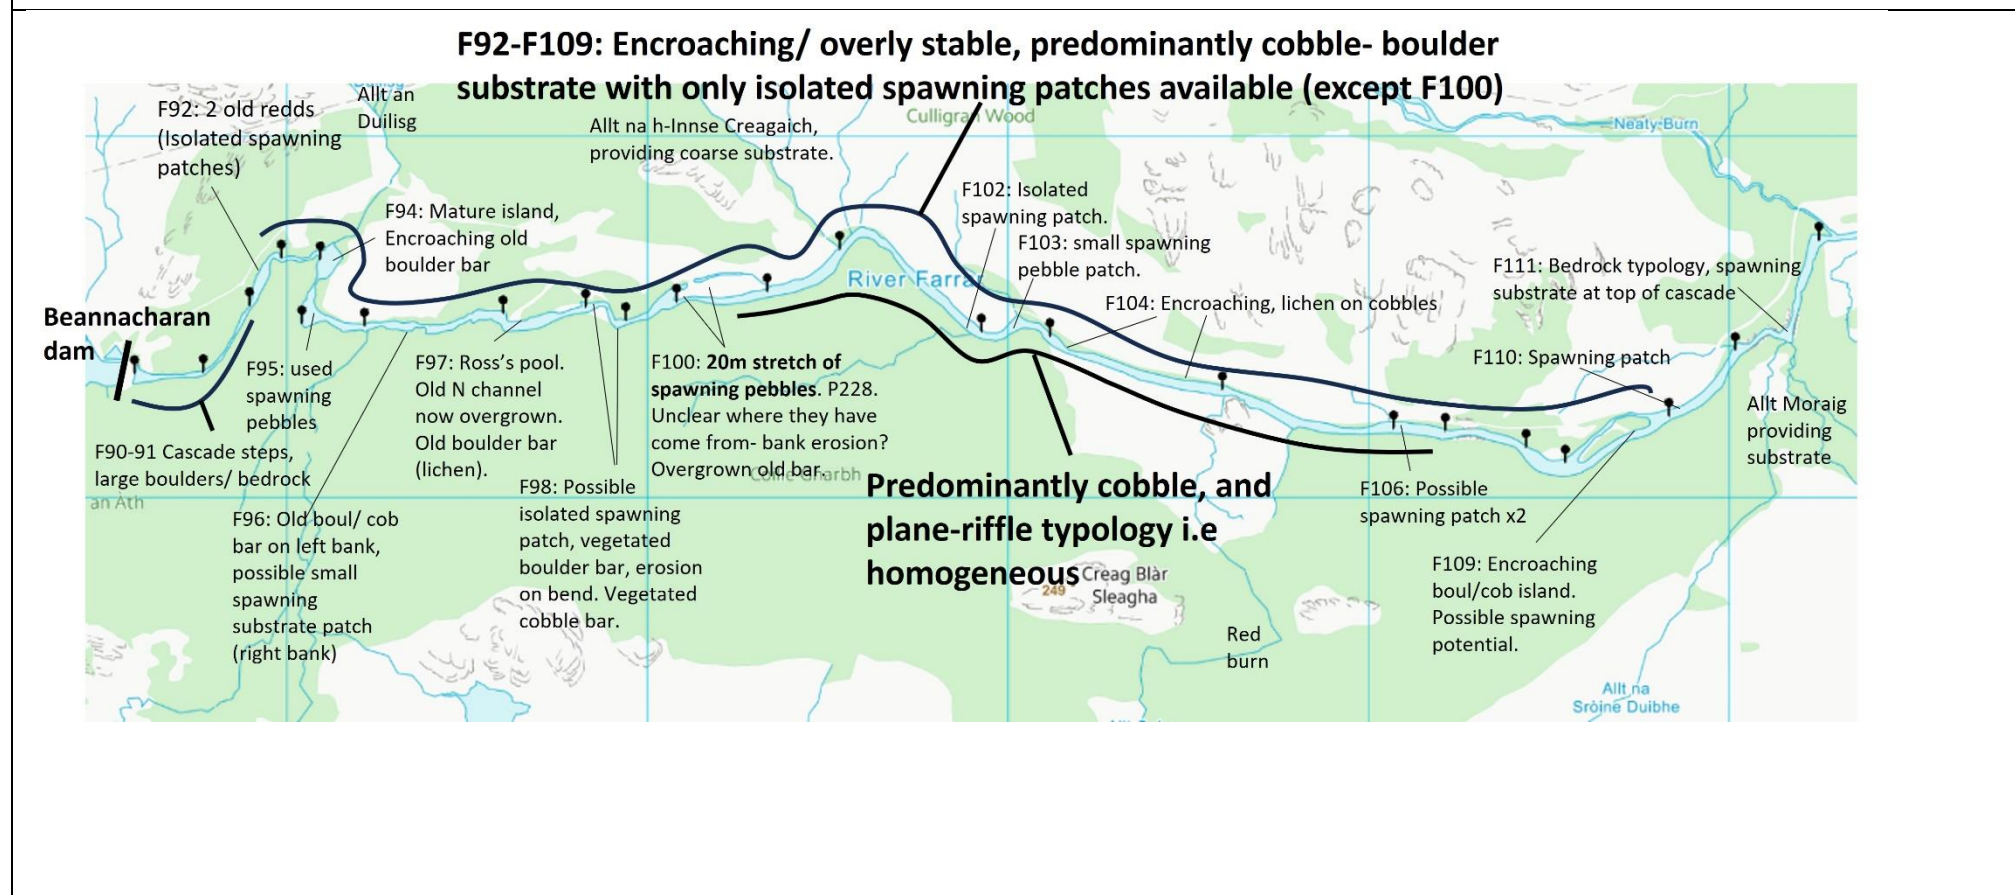
Map 6: Beannacharan dam to Neaty burn

-Overall there seemed to be a **distinct lack of spawning habitat between Beannacharan dam and Neaty burn** with just an occasional old redd or spawning patch observed (except in F100 where a 20m stretch of spawning pebbles occurred). This conclusion was reinforced with consistent observations of encroachment/ and lack of side/ point bars in sections F90-111. Typology was predominantly plane-riffle with low sinuosity. Gradient in the plane-riffle typology sections was seemingly suitable for spawning if the substrate had been present. Despite the homogeneous nature of the channel in the plane-riffle sections, and a relative lack of the gravel/ pebble component, substrate was uncompacted in these sections. **As gradient has not been calculated as part of this report this could be useful to check. This stretch would likely benefit significantly from improved sediment management at Beannacharan dam.**

Neaty and Culligran burns appear to be key substrate providers below Beannacharan dam.

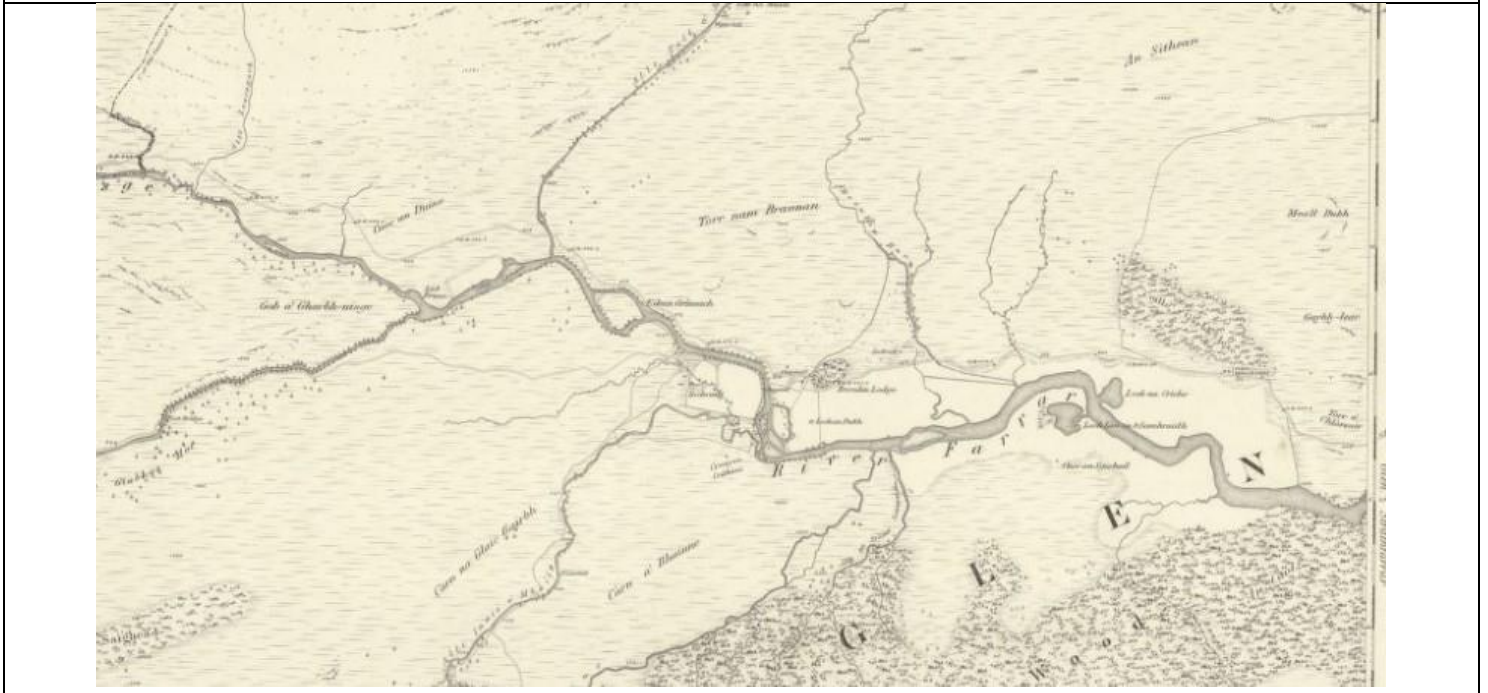
6.3 National Library of Scotland map showing a similar river route to currently observed in front of Braulen lodge.

-It was noted that sections F59-63 contain upland canal (Low Gradient Passive Meandering typology) opposite from Braulen lodge. It was unclear if this was a natural feature of the river profile or not, however a quick look at a historic map on the National Library of Scotland appears to show that the river has taken this form at least since 1875 ([Appendix 6.3](#)).
