## RIVER BEAULY HYDRO-MORPHOLOGY REPORT 2023

Report prepared by Ruth Watts, Senior Biologist | DRAFT, 24/10/23

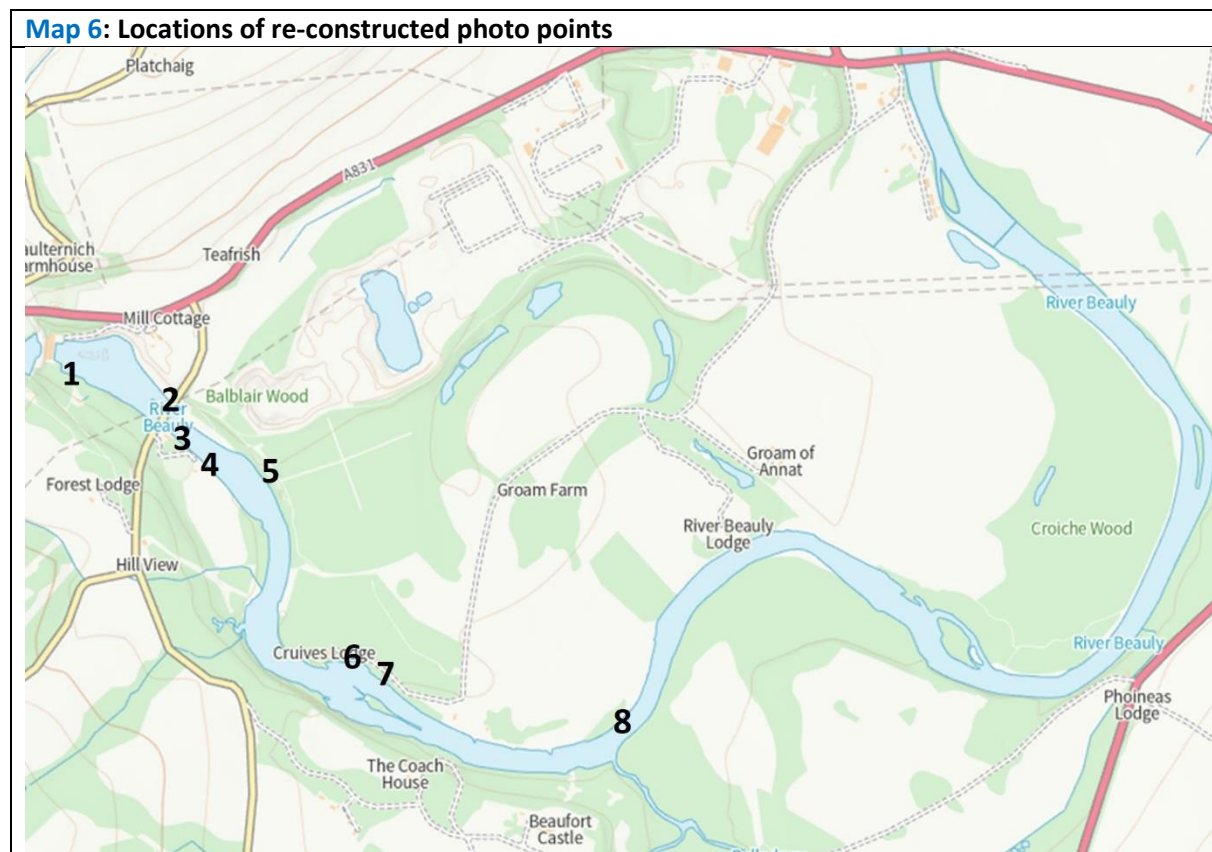
**1) Immediately below Kilmorack dam; NH49549 44106. Willie's grandfather, shortly after dam was built. A mixture of substrate sizes visible.**

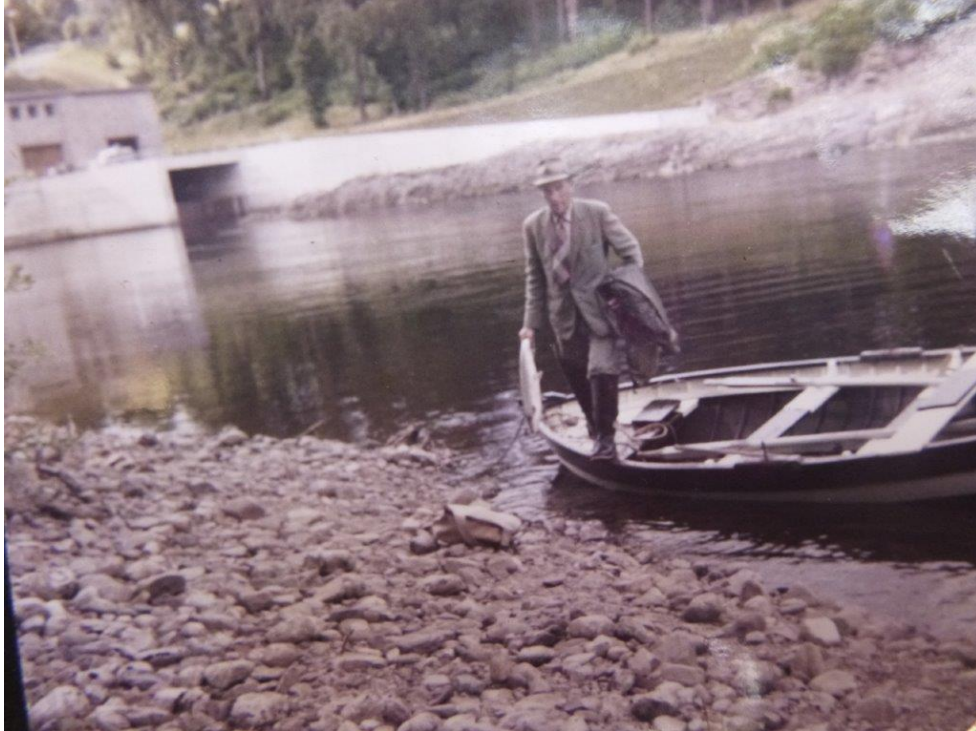
**1) Immediately below Kilmorack dam; NH49449 44106, 19/10/23. Water level higher so substrate not visible, encroaching bank. Walkover (section B24) shows substrate to be predominantly cobble-boulder now.**

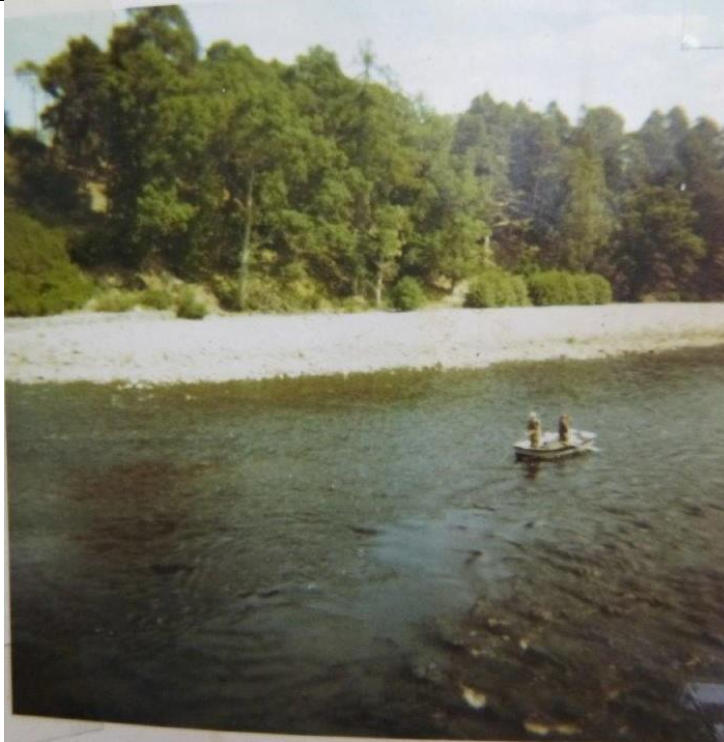
2) Taken from downstream Black bridge. NH49741 43975, 19/10/23. Gravel bar overgrown with trees i.e. stable and undynamic. Also abundance of macrophytes highlighted during walkover (B24).

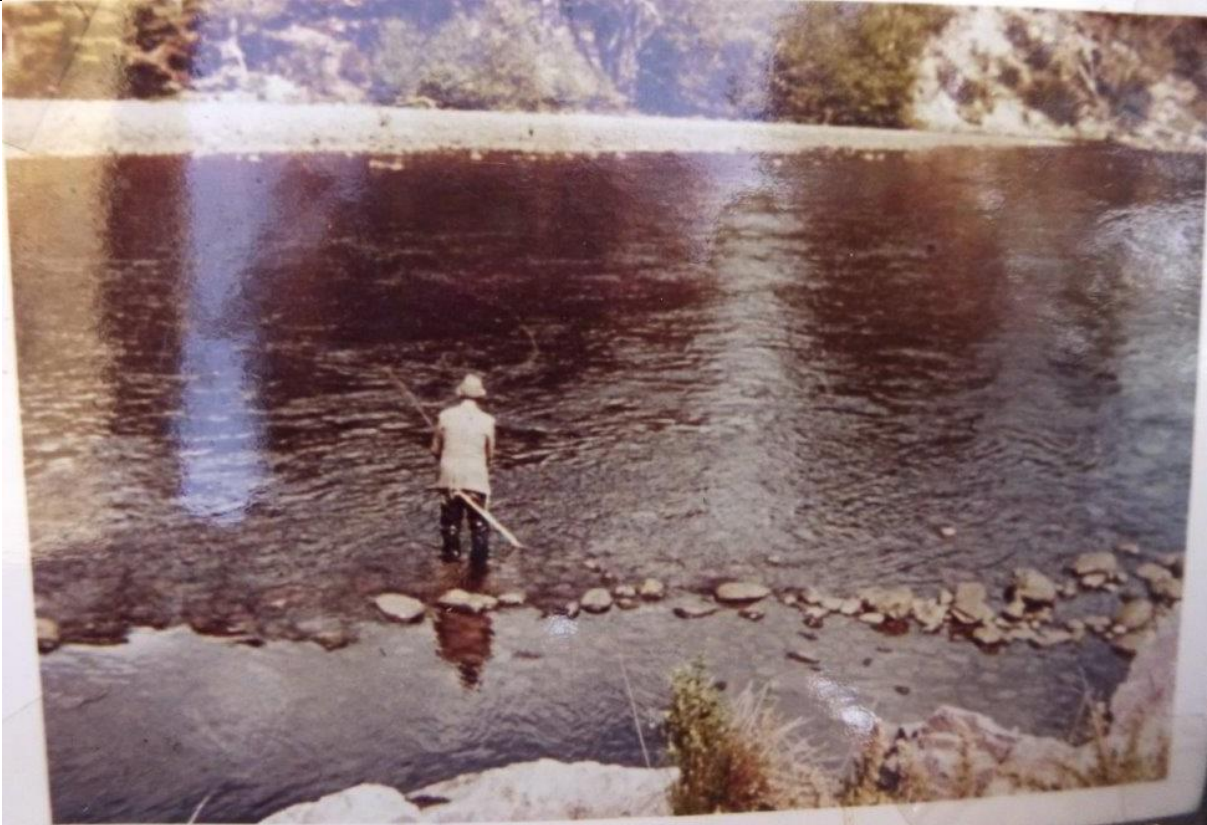
**3) Taken from Falls hut. NH49806 43924, 19/10/23. Bar stable and overgrown. Also flows higher but cobble substrate now boulders. Walkover section B24.**

Anglers who have fished Falls beat for years comment that it is getting more hazardous to fish there due to the now bouldery nature of this beat.

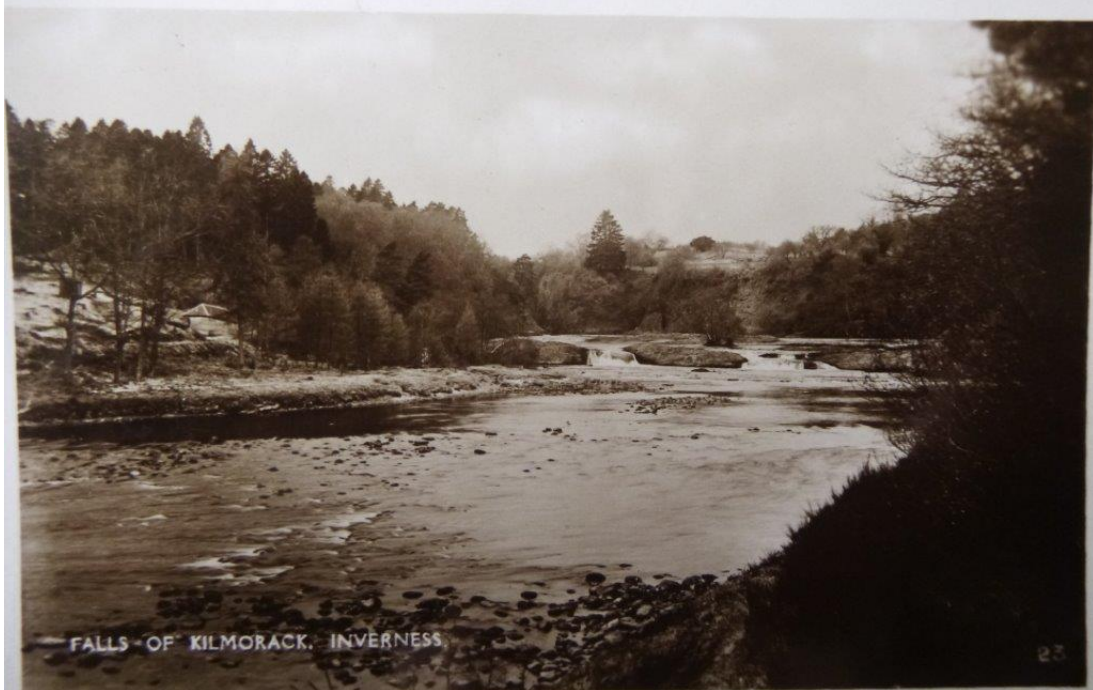
**4) Looking up to Kilmorack dam (where falls used to be) from Black bridge. NH49725 44074, 19/10/23. Island has appeared where cobble riffle used to be, showing stability. (Walkover section B24).**

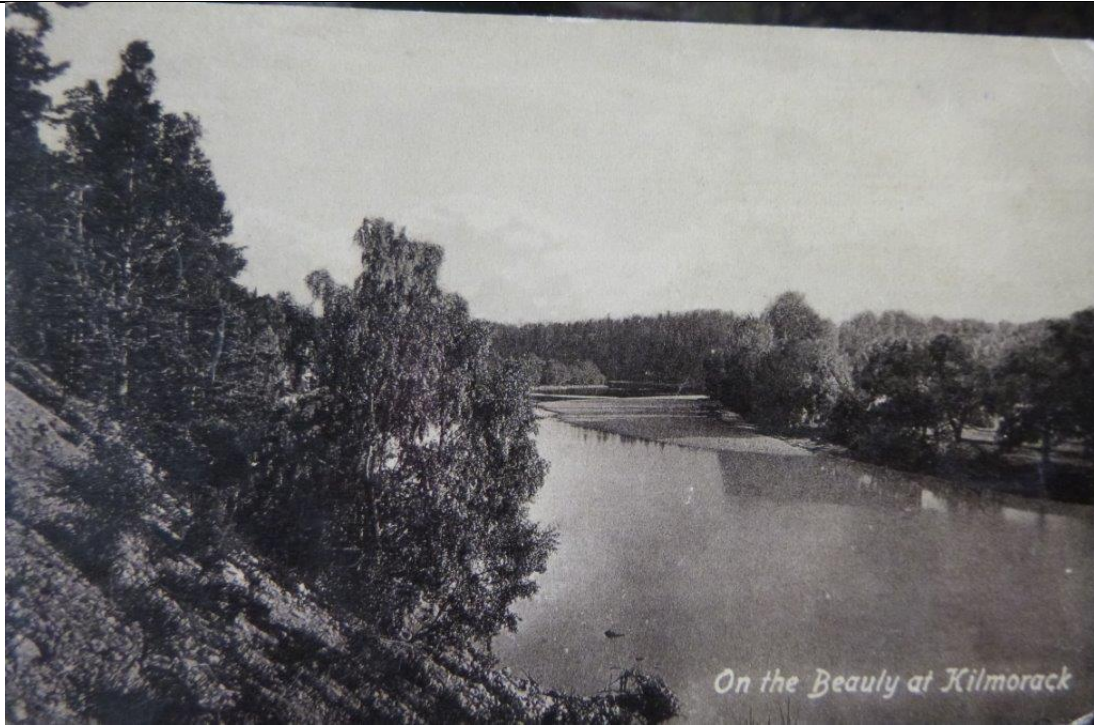
5) Downstream of Black bridge, Kilmorack, New Pool. NH49961 43726. 12/07/2023. Unfortunately the view from the same vantage point is now blocked by trees, however this bar is in walkover section B25 so walkover photo p875 included (taken further downstream, from right bank along bar). Now vegetated.

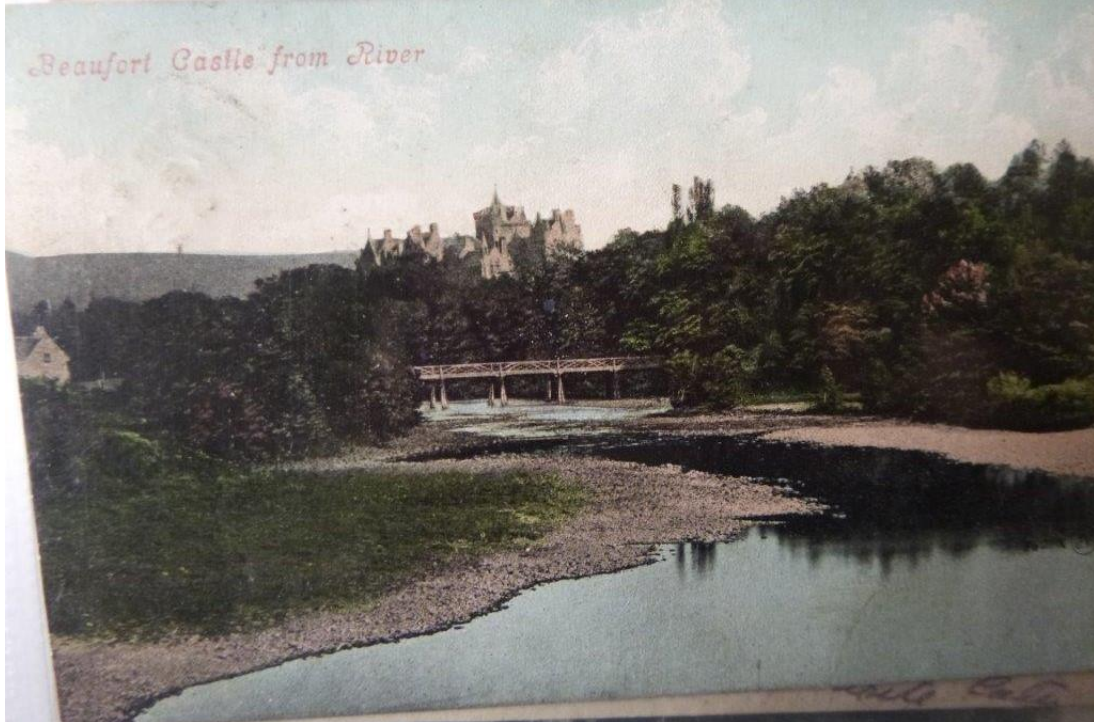
6) Downstream of Cruives, looking to Beaufort castle, Red bridge washed away. NH50134 43430. Higher flow. Pebble/gravel bars not present during walkover (section B26), now predominantly compacted cobble with macrophytes.

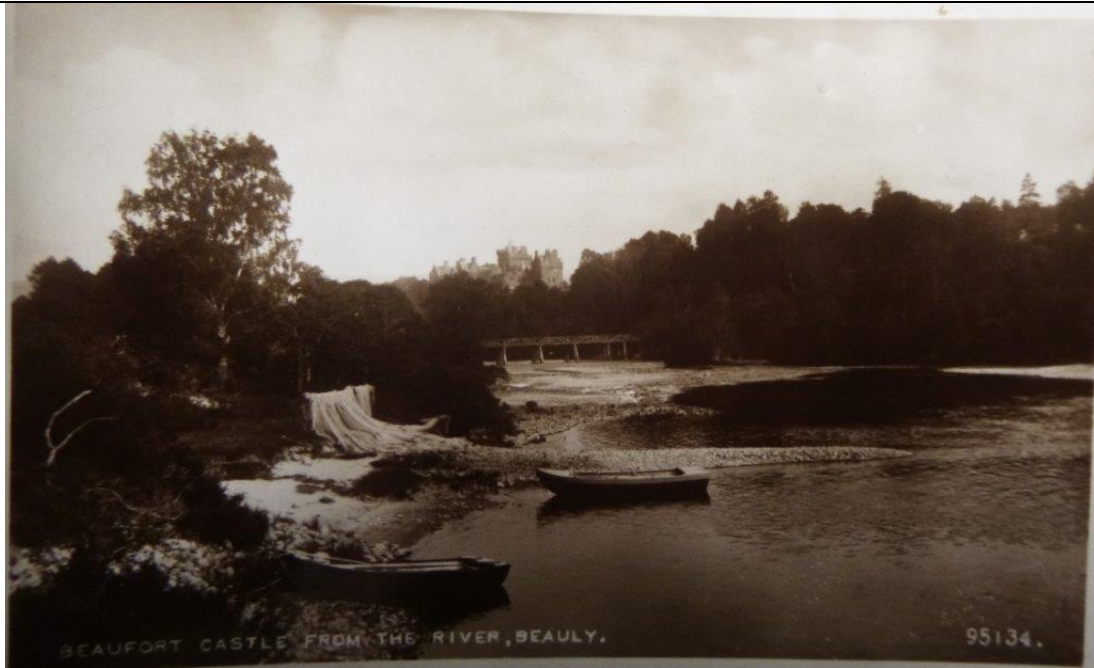
**7)Downstream of Cruives, looking to Beaufort castle and where Red bridge used to be. NH50202 43422. 19/10/23. Higher flow. Walkover shows this substrate is no-longer there (B26).**

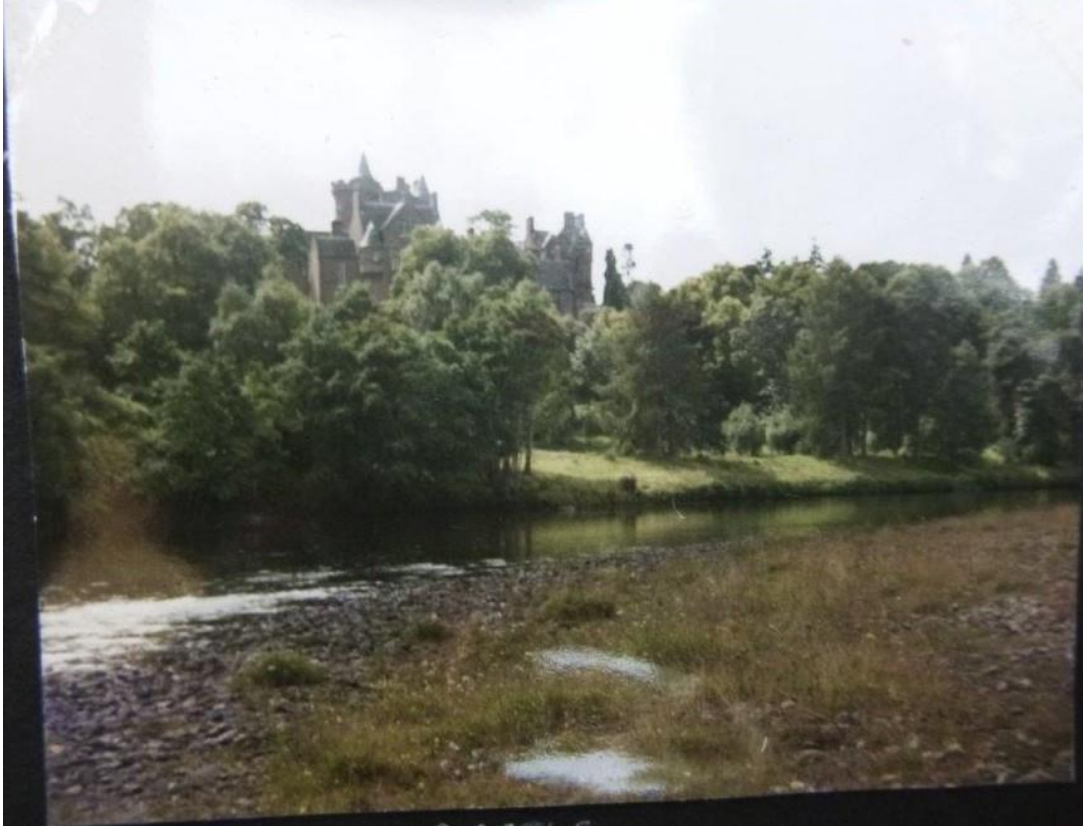
**8) Downstream of Beaufort castle, looking up to Belladrum burn and Beaufort. Photo taken during walkover from further downstream at NH50921 43384 (B27) 12/07/23. Higher flow. Bank is now fully vegetated, and in a defined channel.**
